Scarborough, ME

Payne Road and Gorham Road

Road Safety Audit Report

Virtual RSA meeting: 11/17/2020, Field review: 11/18/2020

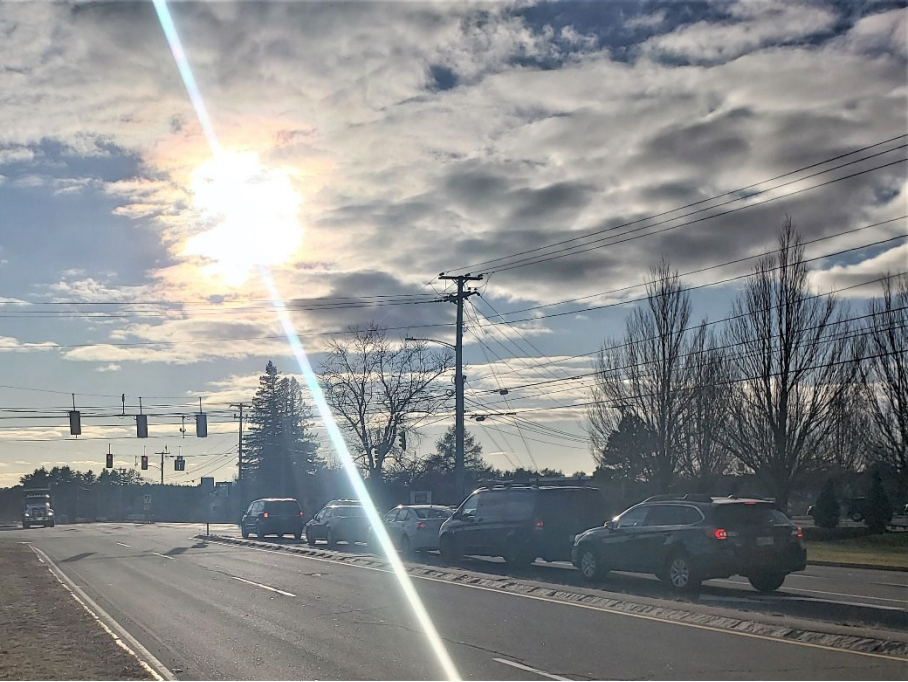
Specific Safety Concern	Suggested Improvements	Example of Issue
<ul style="list-style-type: none"> Vehicles traveling straight through the Gorham Road and Payne Road intersection westbound are running the red light, resulting in crashes with vehicles traveling southbound on Gorham Road. 	<p>Short Range –</p> <ul style="list-style-type: none"> Install retroreflective backplates to improve the visibility of the traffic signals, particularly in situations like the one pictured at right where the sun obscures the traffic signals. Explore improving the coordination of the traffic signal timing at this intersection with upstream traffic signals, including Payne Road and Sam’s Club, Payne Road and Marden’s, and Payne Road and Gallery Boulevard.

<p>Payne Road westbound approach.</p>

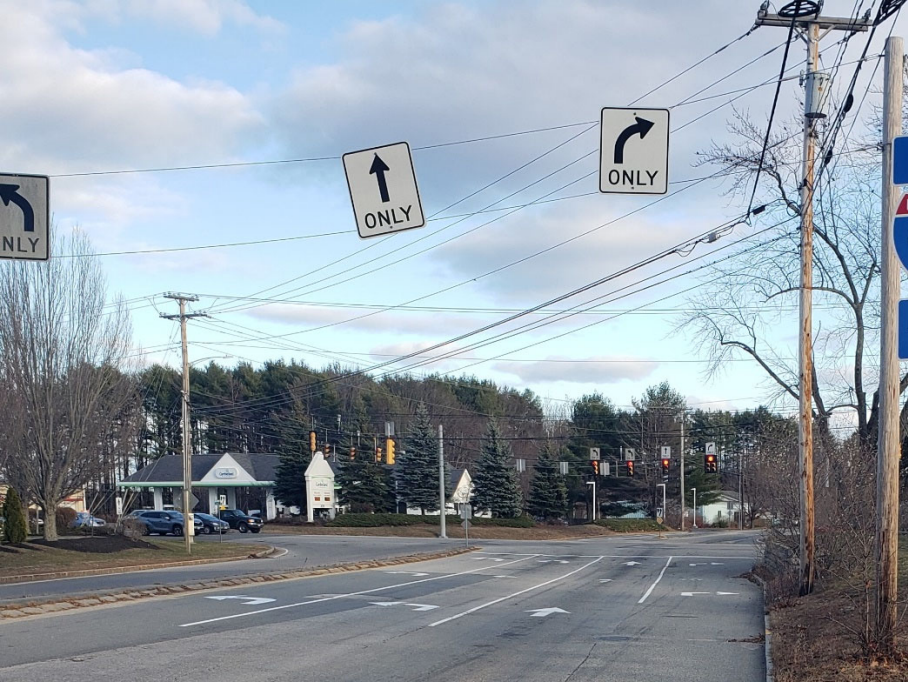
Specific Safety Concern	Suggested Improvements	Example of Issue
<ul style="list-style-type: none"> • Vehicles traveling on Gorham Road, both directions, are rear ending vehicles ahead of them. • Speed is a contributor for southbound vehicle crashes, as vehicles speed down the hill to try and make it through the intersection before it turns red. 	<p>Short Range –</p> <ul style="list-style-type: none"> • Install advanced vehicle detection on both Gorham Road approaches at the Gorham Road and Payne Road intersection. • Install a speed feedback sign at the posted speed reduction location, on southbound Gorham Road.

<p>Gorham Road southbound approach showing lanes and lane assignments.</p>

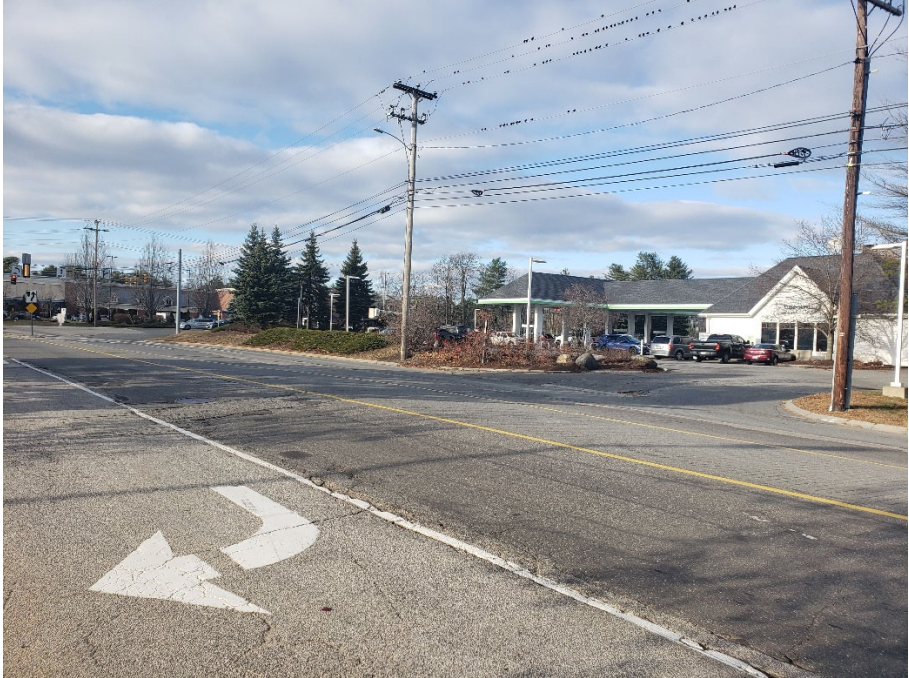
Specific Safety Concern	Suggested Improvements	Example of Issue
<ul style="list-style-type: none"> • Vehicles turning left, into and out of the Cumberland Farms exit onto Gorham Road, are not yielding to through traffic on Gorham Road. • The Cumberland Farms exit is situated at the right turn lane taper before the Gorham Road and Payne Road intersection. 	<p>Short Range –</p> <ul style="list-style-type: none"> • Install a No Left Turn sign in the pork chop island located in the Cumberland Farms driveway. <i>Note: this sign likely existed here previously but may have been hit.</i> <p>Intermediate Range –</p> <ul style="list-style-type: none"> • Extend the median island along Gorham Road to prevent left turns into and out of the Cumberland Farms driveway. • Raise the existing porkchop island at the Cumberland Farms entrance. <i>Note: there is an existing porkchop island that is almost flush with the pavement.</i>

<p>Cumberland Farms entrance/exit on Gorham Road.</p>

Extend median island along Gorham Road to prevent left turns into and out of Cumberland Farms at this exit.	Would require vehicles that want to travel south on Gorham Road to turn left out of Cumberland Farms on Payne Road and then left again onto Gorham Road at the intersection.	Moderate
	Raise porkchop island in Cumberland Farms drive.	Would need to ensure that a fire truck can still easily access Cumberland Farms.	Moderate

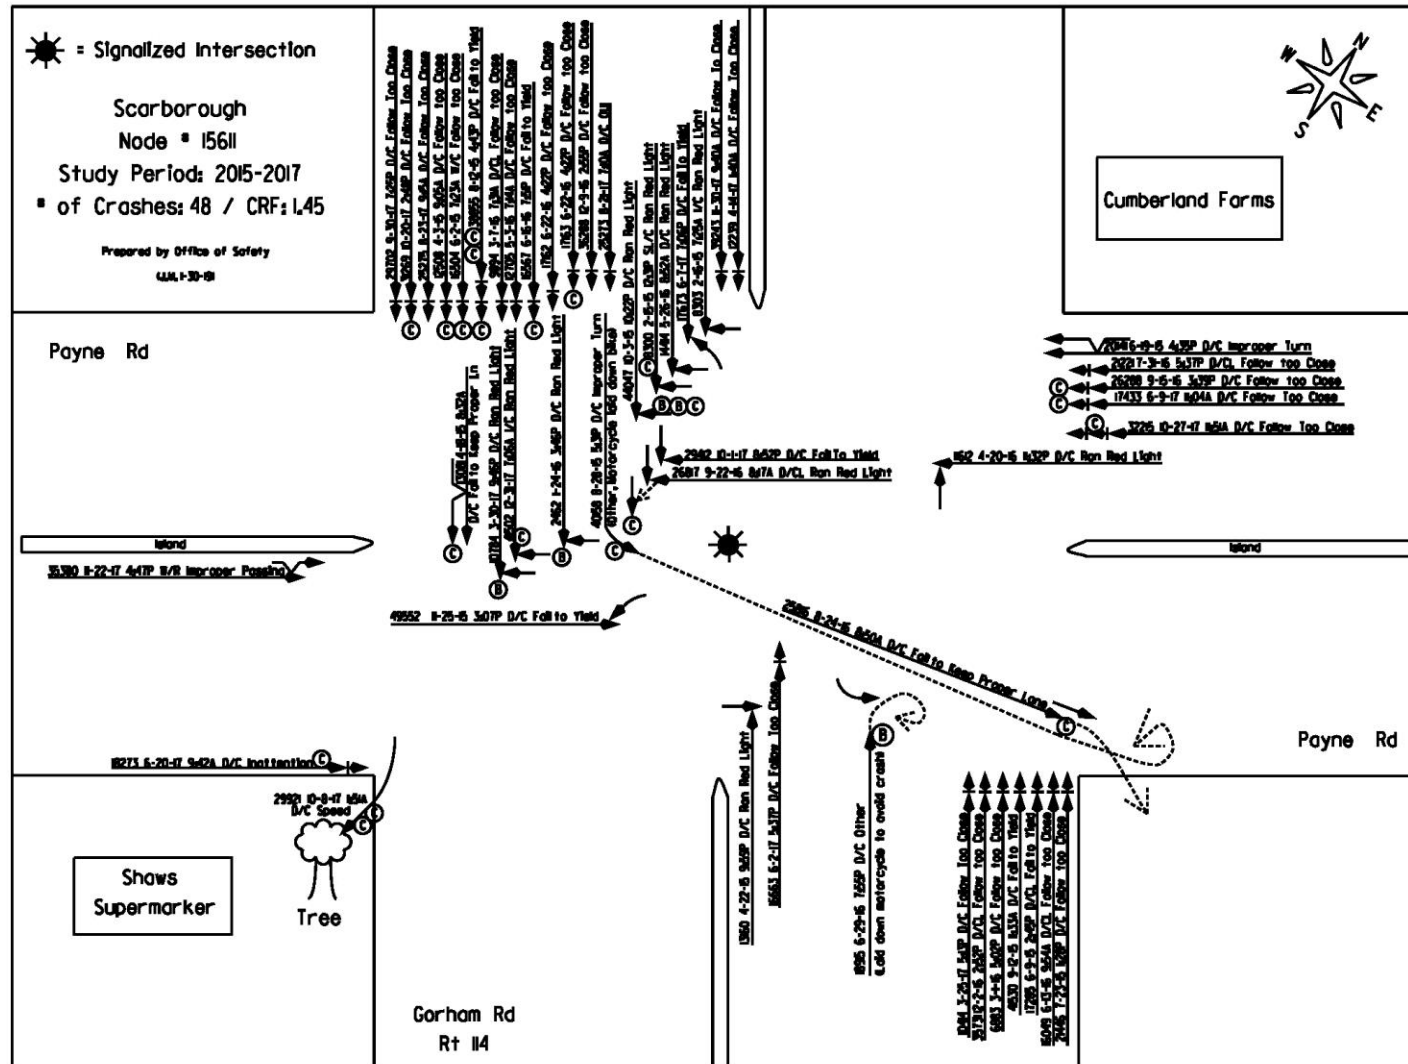
A. Intersection of Payne Road and Gorham Road

There were 48 crashes at the intersection between 2015-2017, most of which were rear end or angle crashes. The majority of the crashes (28 of the 48) involved vehicles traveling eastbound on Gorham Road. Eight of the 28 involved a vehicle running a red light. There were two additional red-light-running crashes involving vehicles on other legs of the intersection. Additionally, quite a few vehicles are running the red light at this intersection. In particular this is a problem with vehicles traveling South on Payne Road.

The most prevalent crash type on both southbound Payne Road and westbound Gorham Road was rear end.

Note: the businesses are labeled incorrectly. Cumberland Farms should be in the southeast corner and Sam's Club should be in the northeast corner.
