DRAFT FINAL REPORT

SACO AND SCARBOROUGH ROUTE 1 CORRIDOR COMPLETE STREETS PLAN

June 4, 2019

prepared by:
TYLIN INTERNATIONAL

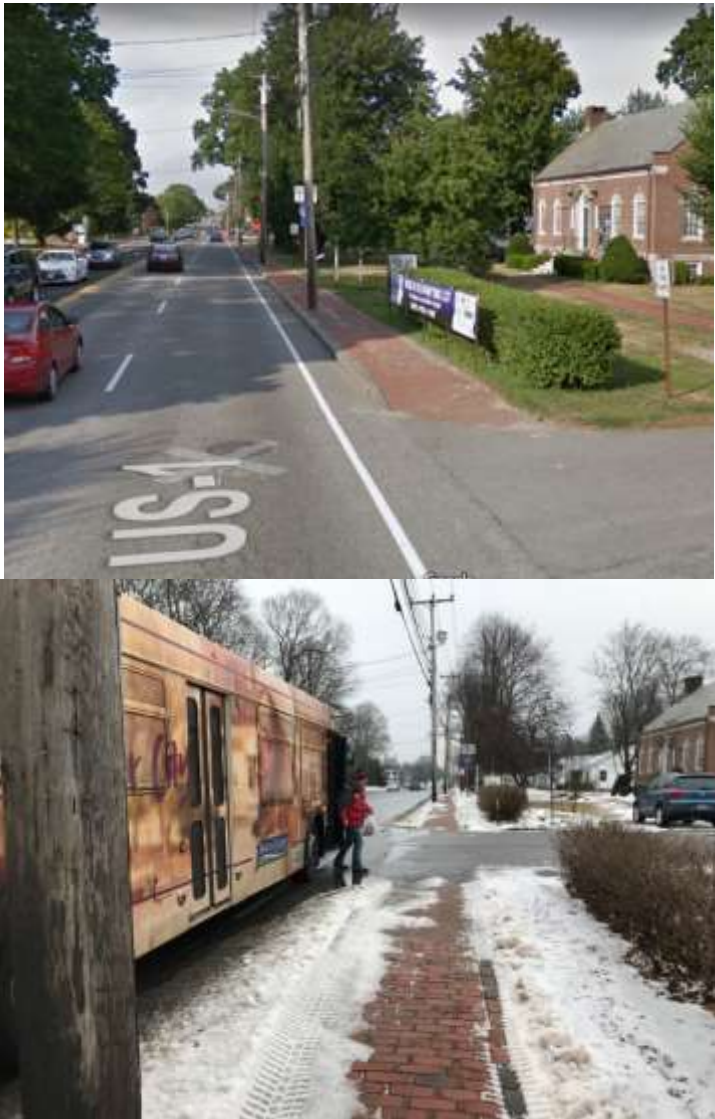
Dyer Library (NB)

The stop at Dyer Library is located far-side of the driveway to the library parking lot. There is a narrow shoulder (approximately 2 feet wide) and the bus stops in the right lane. The sidewalk is just over 5 feet wide, 3 feet short of the space required for an ADA landing area, and sidewalk space is further reduced where utility poles cause a pinch point. The brick sidewalk is uneven and does not provide a level landing area. There are curb ramps at the driveway to the library, but both lack detectable warning panels (DWP). There is no crosswalk across Main Street at this location. There is a fully accessible signal with audible detection at the intersection of Main Street and Beach Street, approximately 475 feet from the stop. The stop lacks bus stop signage and pedestrian scale lighting. Overall the stop is in fair condition. A southbound pair was not identified for this stop.

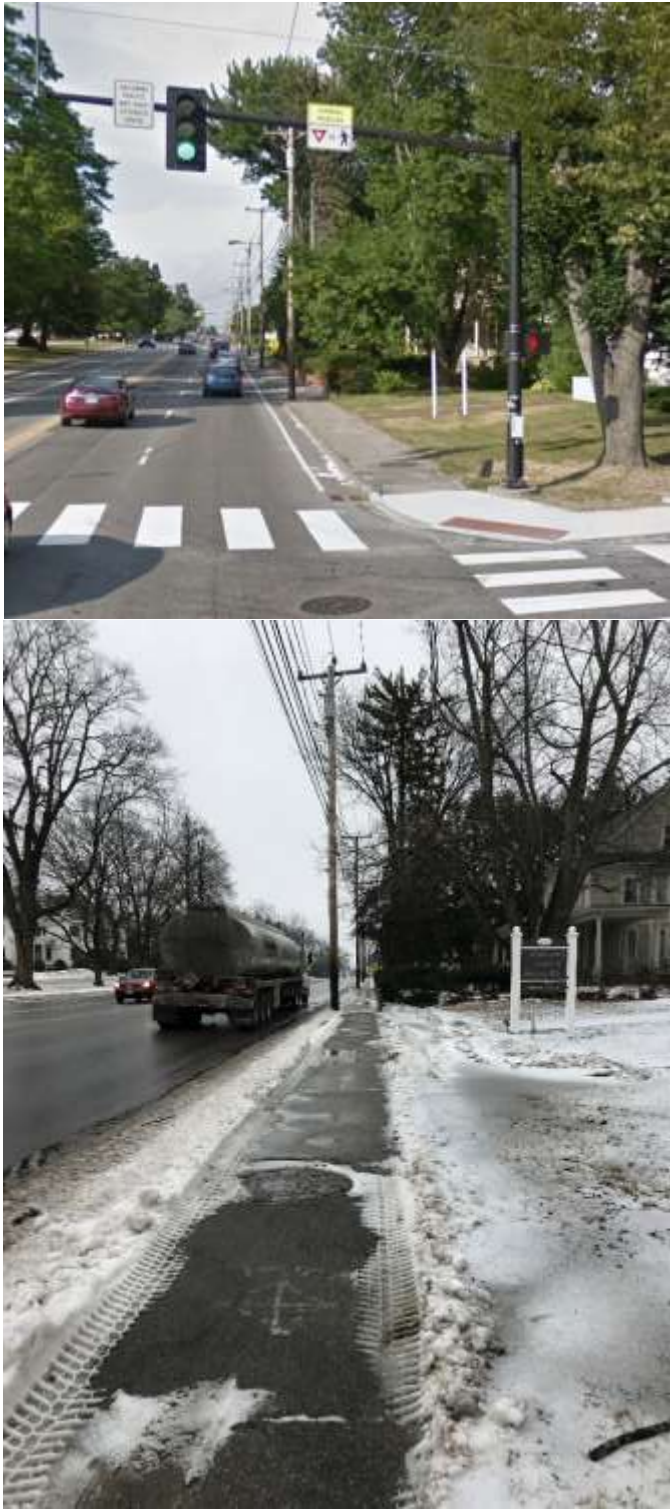
Thornton Academy King Street (NB)

The Thornton Academy northbound stop is located far-side of the intersection of Main Street and King Street. There is a narrow shoulder (approximately 1-foot wide) and the bus stops in the right lane. The asphalt sidewalk is approximately 6 feet wide, 2 feet short of the space required for

an ADA landing area and has multiple transverse cracks. There is a 5-foot pinch point at the utility pole. The intersection is signalized with continental style crosswalks across each approach except for the southern leg across Main Street. The intersection is signalized with continental style crosswalks across each approach, except for the southern leg across Main Street where there is no crosswalk, although there is a second curb ramp on the southern corner that suggests there may have been a crosswalk at one point. Each crosswalk has an Accessible Pedestrian Signal (APS) with audible detection. Although there are curb ramps on each end of each crosswalk, they appear to warrant improvement so that the ramps better align with the crosswalk entrances and provide upgraded Detectible Warning Panels (DWP). The stop lacks bus stop signage and pedestrian scale lighting, although there is a street light on a utility pole on the southwest corner of the intersection of Main Street and King Street. Overall the stop could be rated as good.

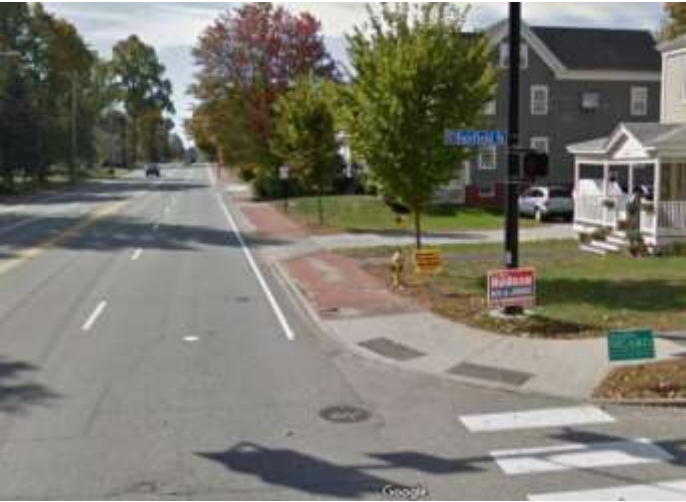
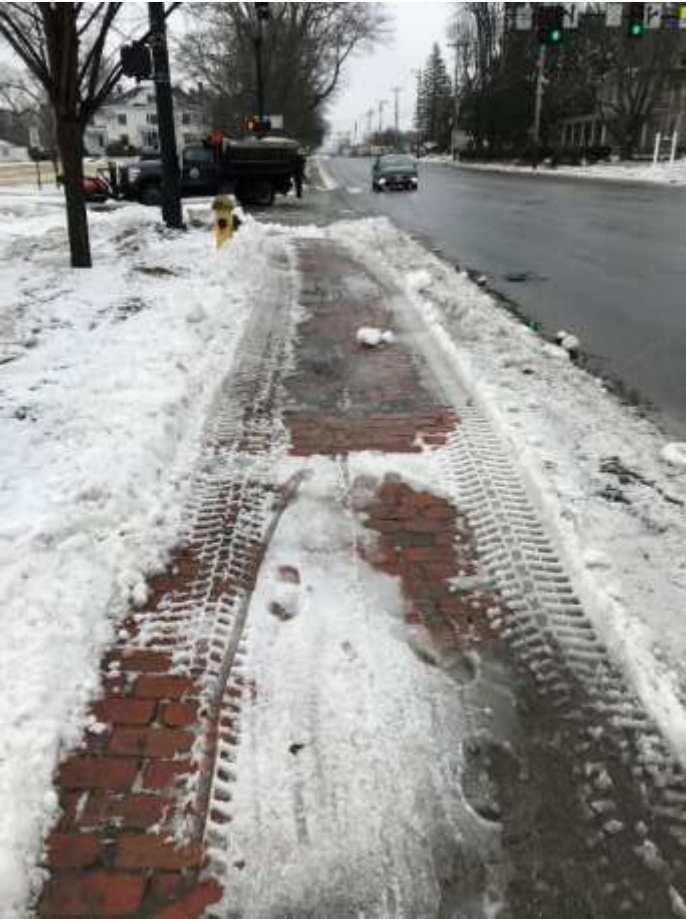
Thornton Academy Fairfield Street (SB)

The Thornton Academy southbound stop is located far-side of the intersection of Main Street and Fairfield Street. There is a narrow shoulder (approximately 1-foot wide) and the bus stops in the right lane. The sidewalk is approximately 5 feet wide - 3 feet short of the space required for an ADA landing area, mostly brick, but appears to be uneven, cracked, and debris appears to gather in sidewalk depressions. The level sidewalk space

available for the bus stop is about 30 feet between the curb ramp and the driveway. See the northbound pair for overall description of intersection elements. The stop lacks bus stop signage and pedestrian scale lighting. Overall the stop is in fair condition.

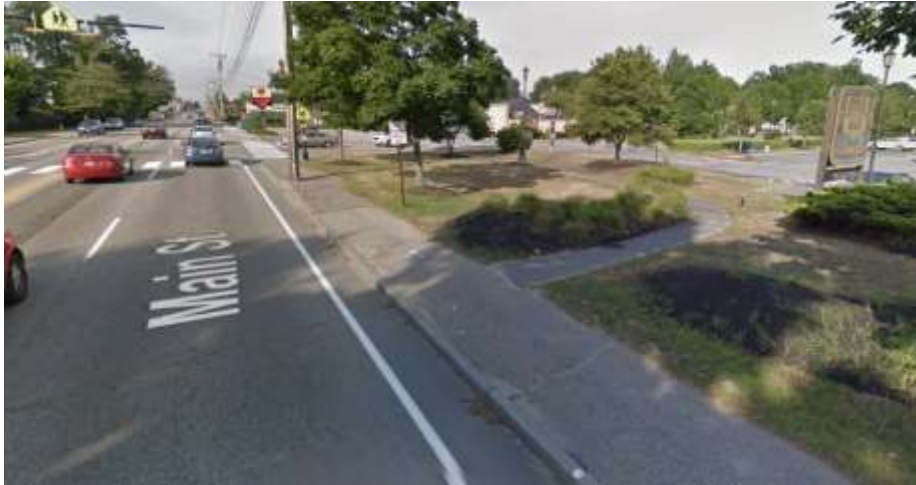
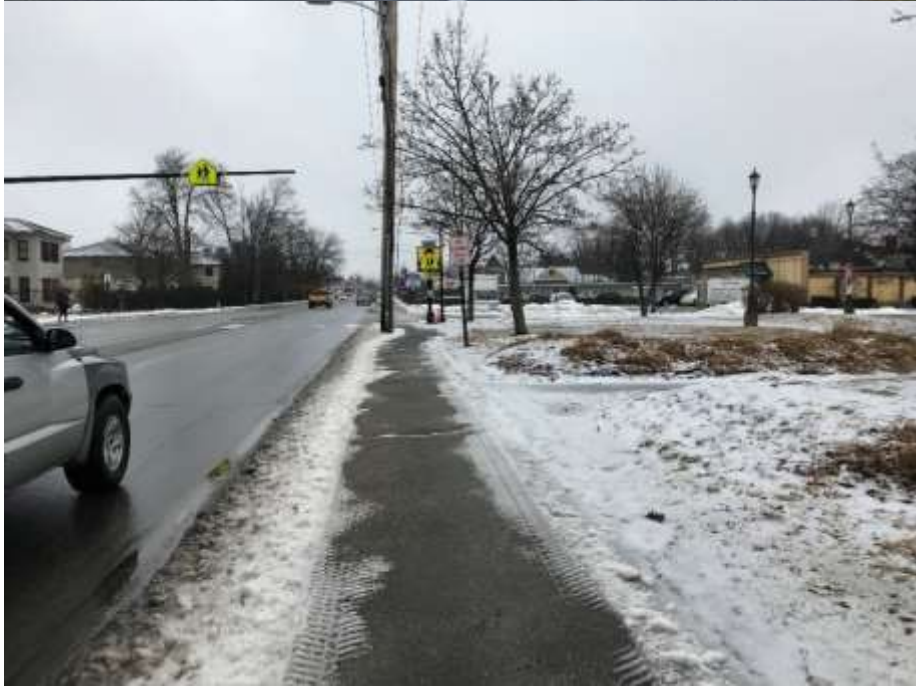
Rite Aid Smith Lane (NB)

The stop at Rite Aid is located near-side of the intersection of Main Street and Smith Lane. There is a narrow shoulder (approximately 2 feet wide) and the bus stops in the right lane. The asphalt sidewalk is about 5.5 feet wide, 2.5 feet short of the space required for an ADA landing area, with multiple transverse cracks at an approximately 5.6% slope which exceeds the 2% maximum requirement to meet the ADA standards. There are crosswalks across two legs of the intersection. The Main Street crossing has a Rectangular Rapid Flash Beacon (RRFB) and the Smith Lane crossing is

unsignalized. While there are curb ramps for all sidewalk connections to the crosswalks, there are no DWP and they do not appear to meet the ADA. Overall the stop could be rated as good. The stop lacks bus stop signage and pedestrian scale lighting, although there is a street light on the utility pole just prior to the RRFB. A southbound pair was not identified for this stop.

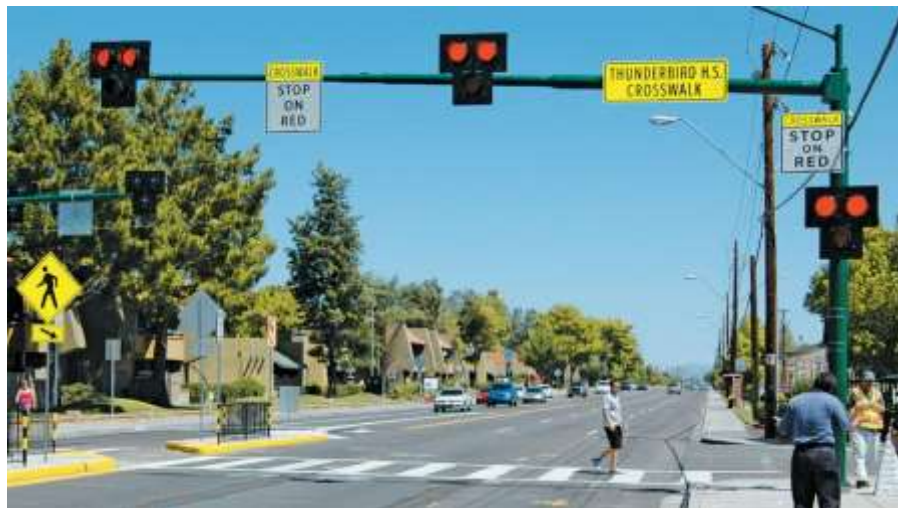
With the current RRFB not being effective enough, a Pedestrian Hybrid Beacon (PHB) is recommended. A PHB is a traffic control device designed to help pedestrians safely cross busy or higher-speed roadways at midblock crossings and uncontrolled intersections. The beacon head consists of two red lenses above a single yellow lens. The lenses remain "dark" until a pedestrian desiring to cross the street pushes the call button to activate the beacon. The signal then initiates a yellow to red lighting sequence consisting of steady and flashing lights that directs motorists to slow and come to a stop. The pedestrian signal then flashes a WALK display to the pedestrian. Once the pedestrian has safely crossed, the hybrid beacon again goes dark. The crosswalk is approximately 50 feet wide with total peak hour volumes of 1795 during the AM peak hour and 2060 vehicles during the PM peak hour. The Manual on Uniform Traffic Control Devices (MUTCD) has established a peak hour pedestrian volume warrant of 20 pedestrians per hour for the vehicle volume noted. Given the proximity to Thornton Academy this crossing likely meets the warrant. An example of a PHB is shown below.

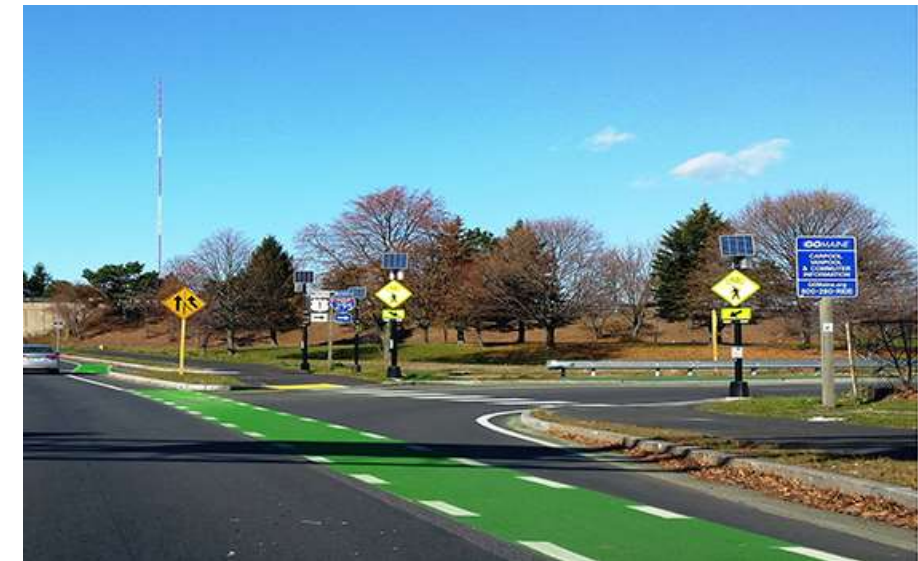
The existing flashing warning beacons at the Eastern Trail crossings with the I-195 ramps are outdated and should be replaced with Rectangular Rapid Flashing Beacons (RRFB). An example of an RRFB for a multi-use path in Portland is shown below

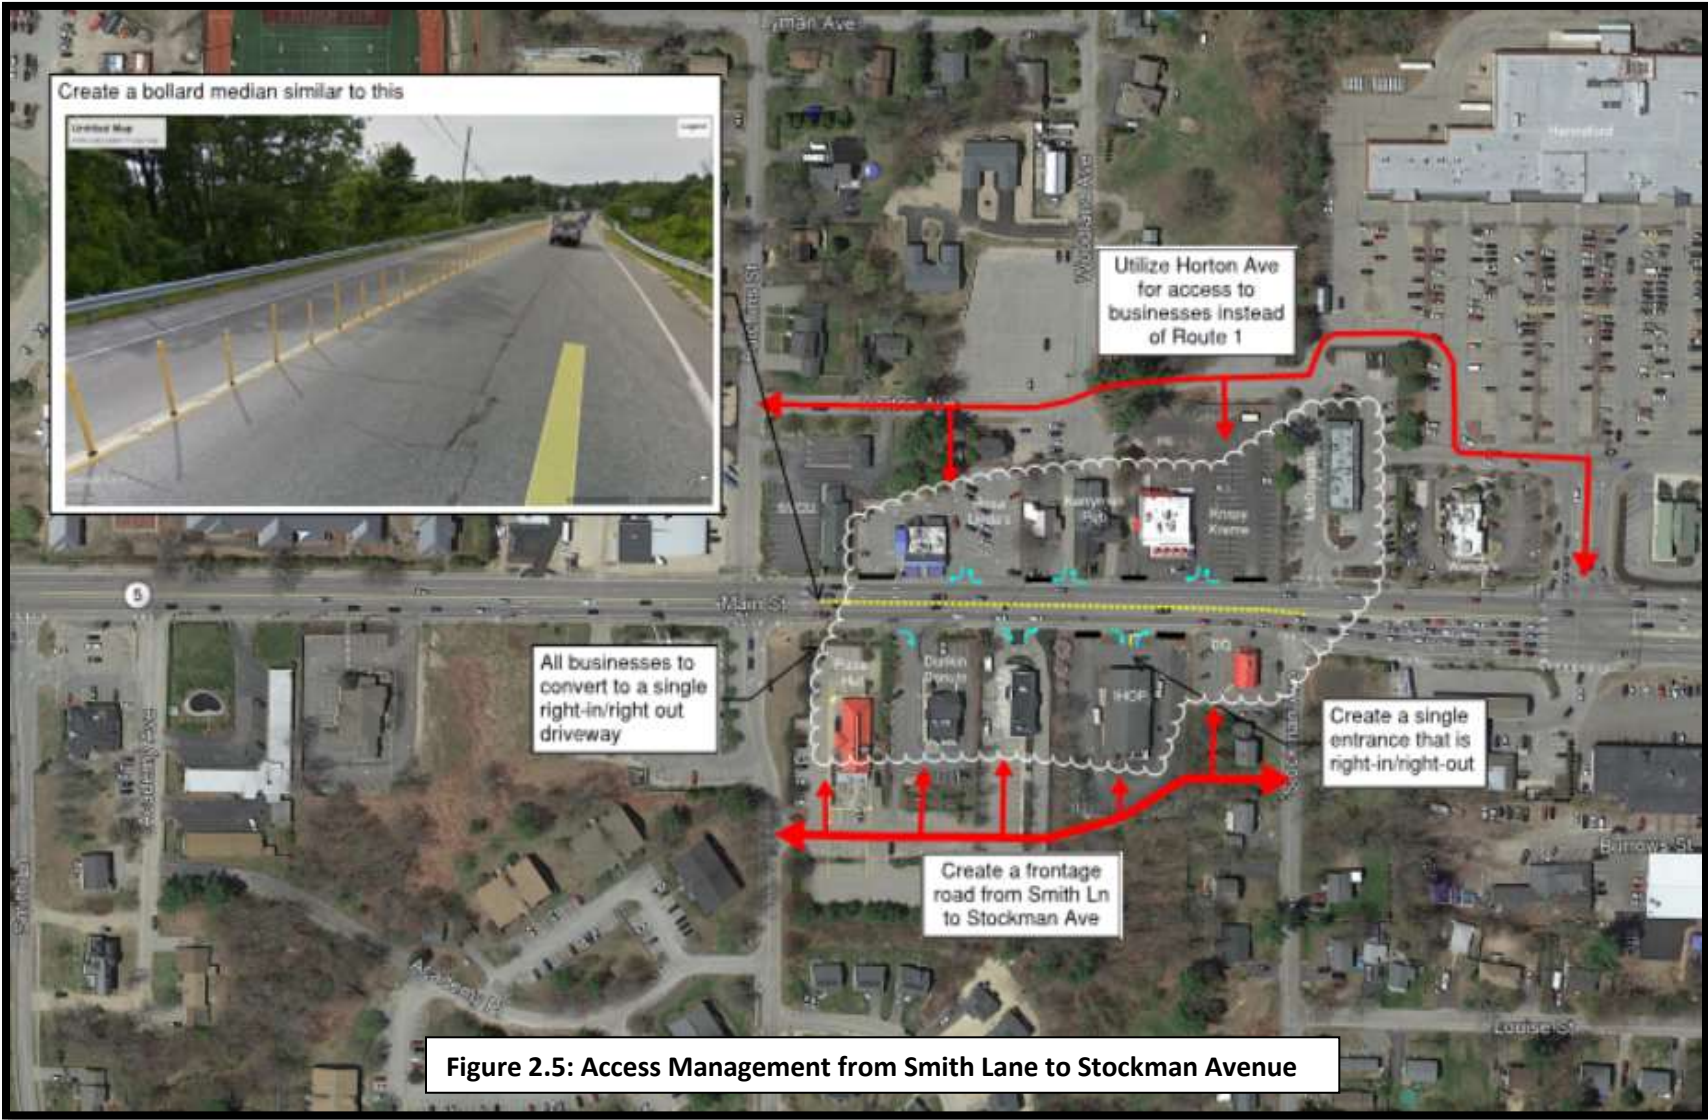
Figure 2.5: Access Management from Smith Lane to Stockman Avenue

The stretch between Ocean Park Road and Smith Lane has a very dense cluster of significant trip generators such as fast food restaurants. To improve mobility in this area, a bollard median is recommended as shown below in **Figure 2.5** between Smith Lane and Stockman Avenue. A bollard median will not require widening the roadway and can still be mounted by emergency vehicles.

The median and frontage road will lead to an increase in left turning vehicles at the Smith Lane signal. Unfortunately, there is no opportunity to widen the intersection to provide left-turn lanes. Instead, a modified four lane section with two southbound lanes, a left turn lane, and one

northbound lane is currently being evaluated. This analysis will be provided when completed.

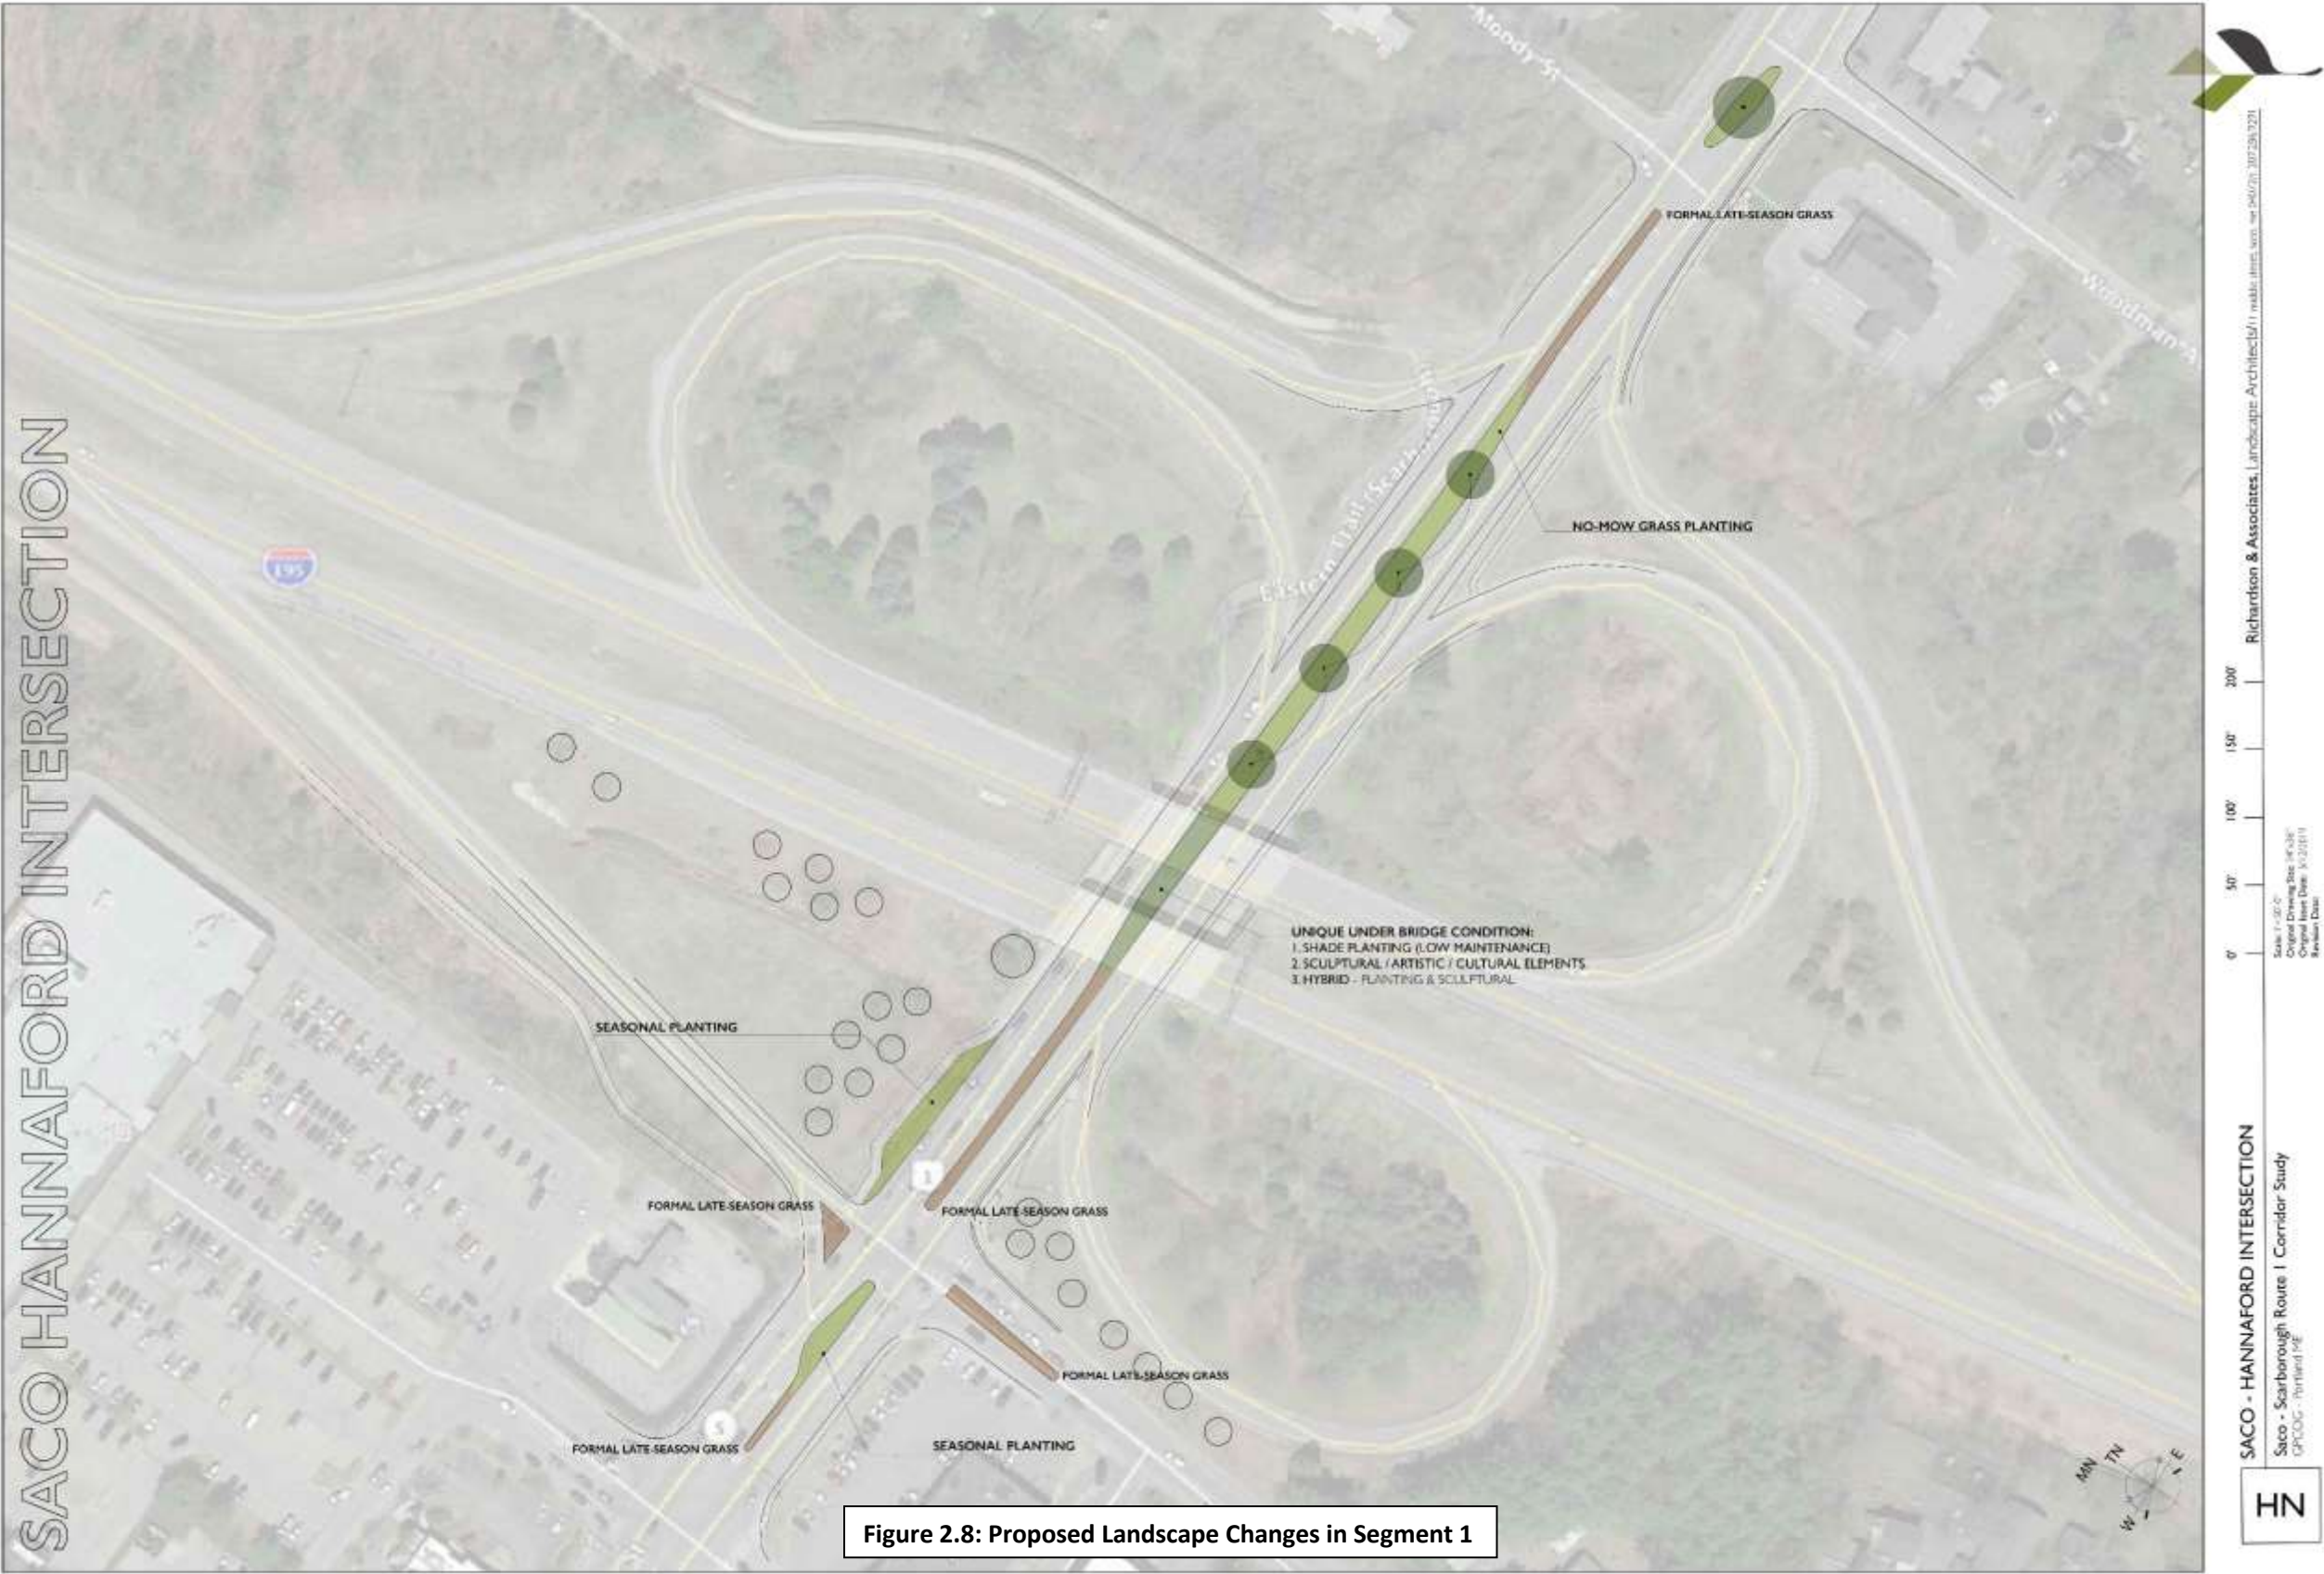
Figure 2.8: Proposed Landscape Changes in Segment 1

Vehicular movement and traffic are significant in this area. Minimal, if any physical changes can be made to improve and increase pedestrian safety from the Hannaford entrance to beyond the multiple Eastern Trail crossings located along the southbound corridor. However, landscape improvements that seek to scale and exploit the bridge overpass create opportunities for community expression and beautification. **Figure 2.8** presents landscape recommendations.

Public art identifying and magnifying place, is encouraged for under the I195 bridge abutments. A mix of media types and/or landscape treatments would integrate with the concrete structures that currently exist. This is a highly visible and congested area – particularly in the summer, when tourist populations significantly increase. The overall goal and objective are to provide visitors and commuters an opportunity to learn and engage with the place (Saco) and its cultural milieu – while migrating slowly through multiple intersections and signal areas.

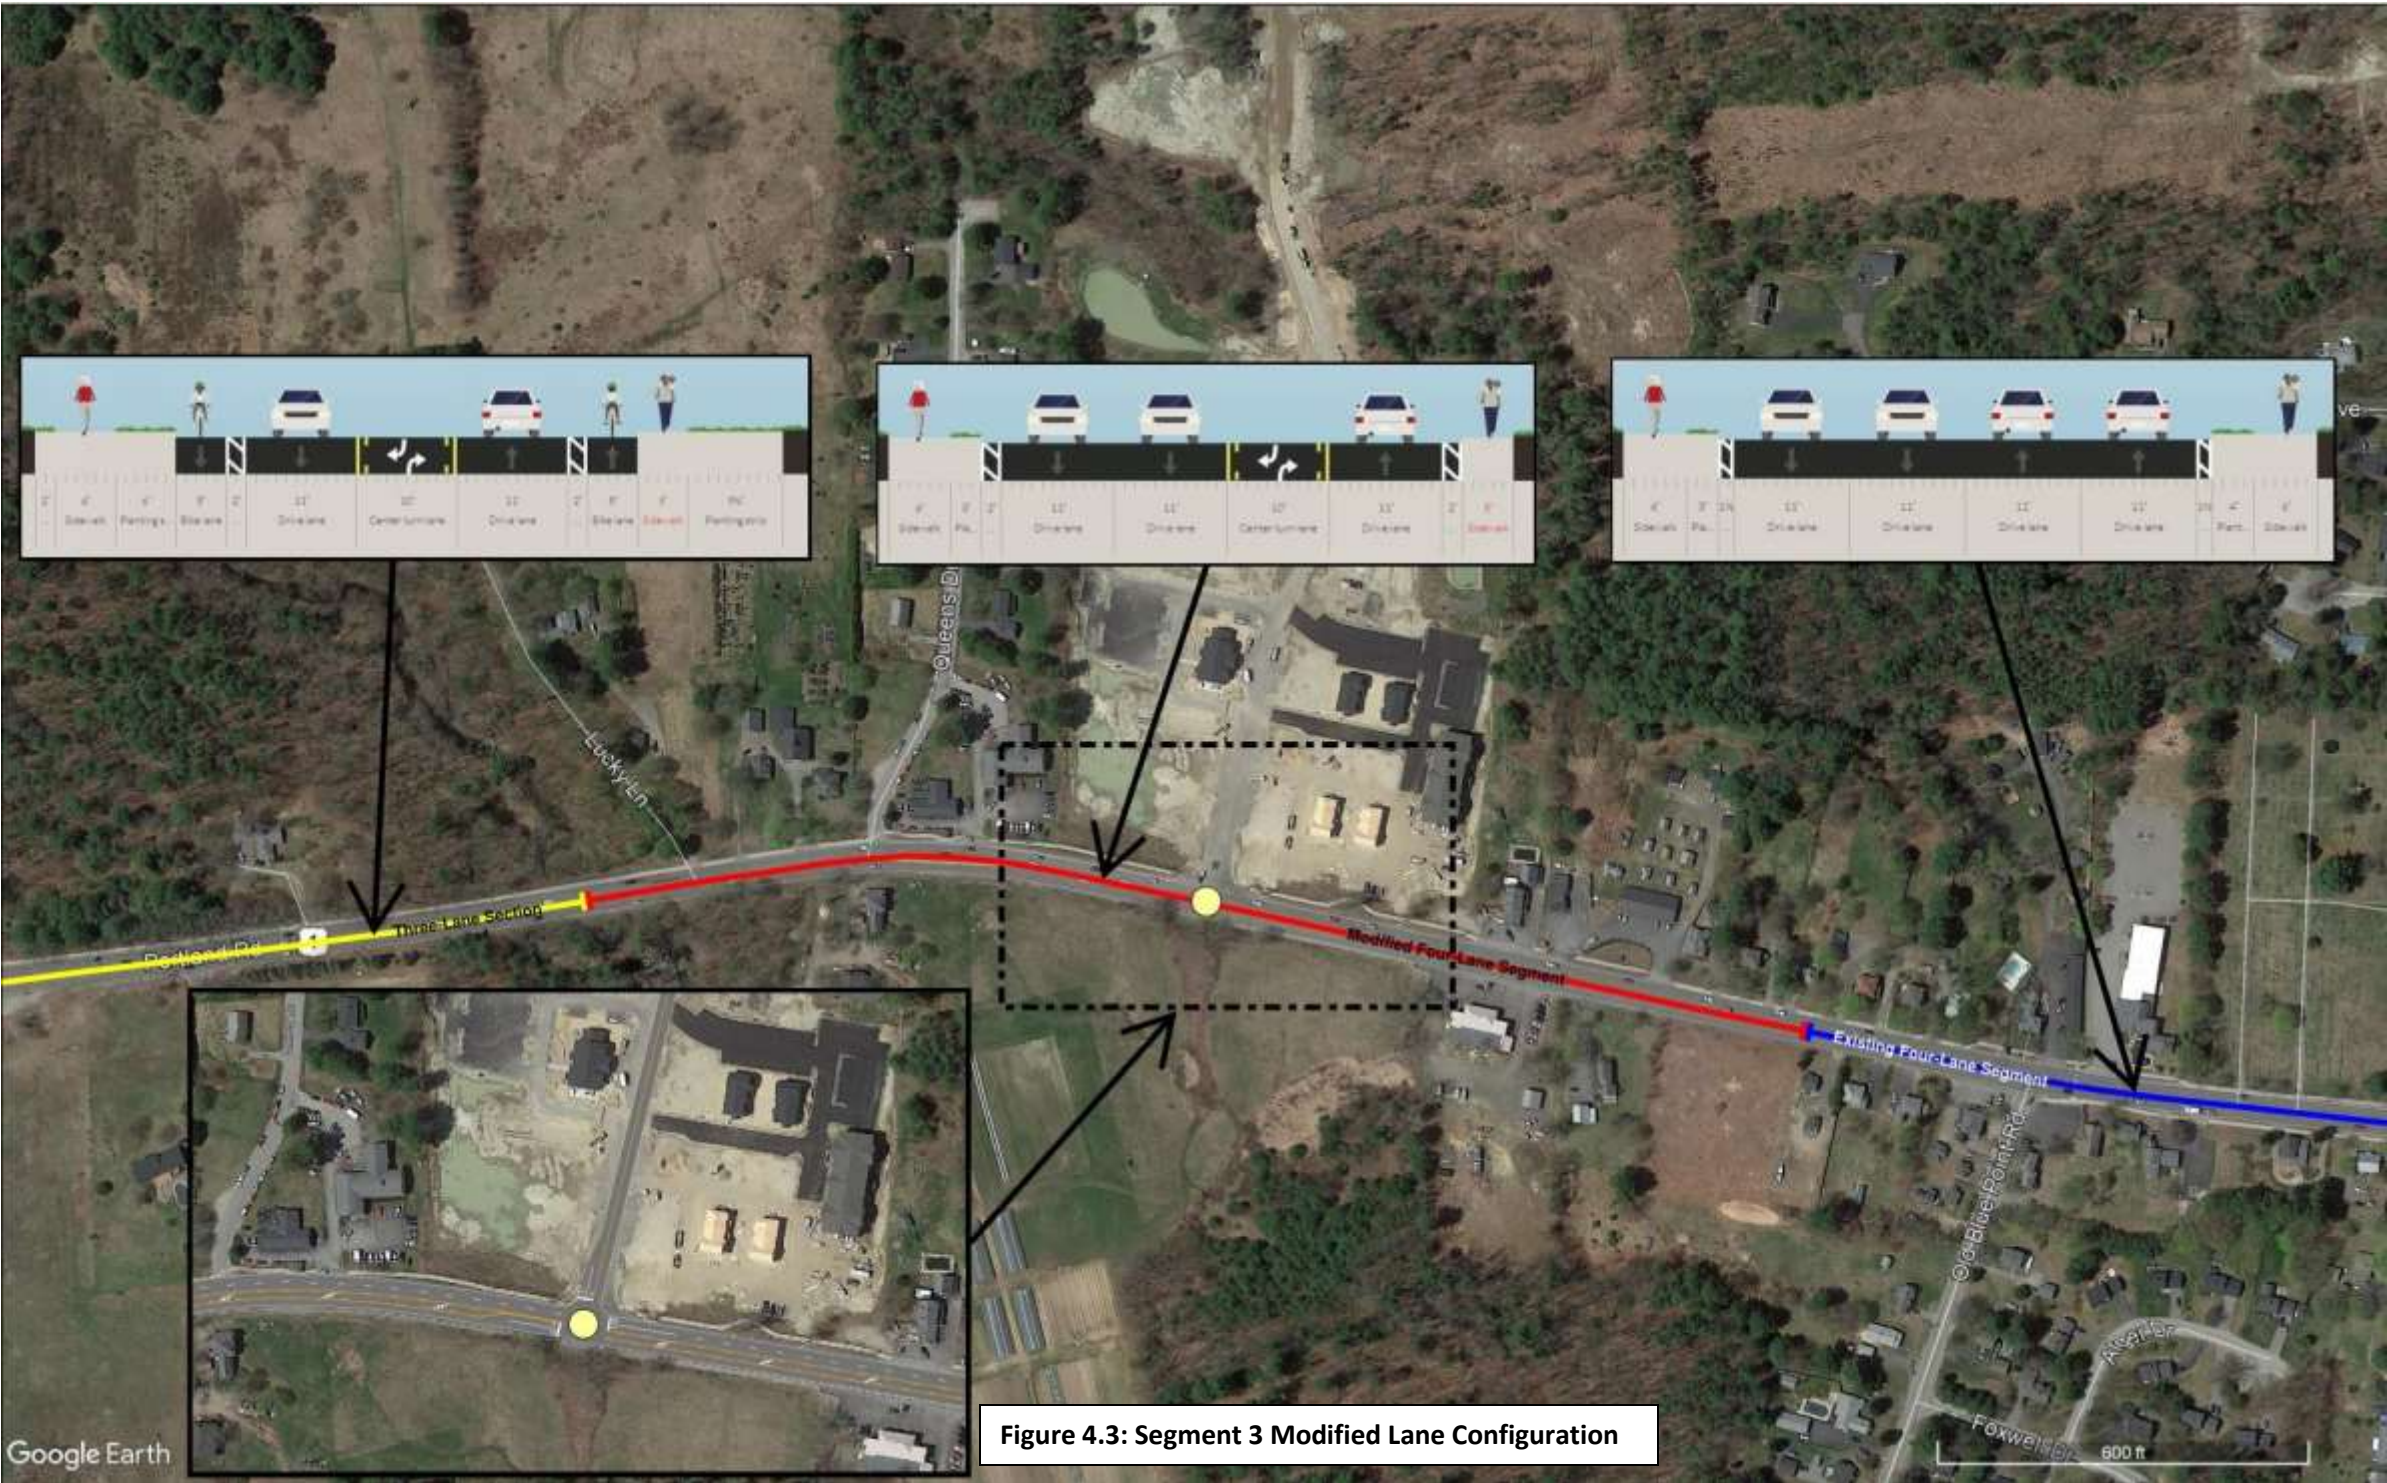
Figure 4.3: Segment 3 Modified Lane Configuration

Table 4.2 presents an evaluation of Route 1 and Old Blue Point Road with the previously noted lane alternatives. The three-lane alternative with one lane northbound on Route 1 is inadequate for the high volume of right turning traffic turning off of Old Blue Point Road in the morning. The five-lane section works similarly to the existing four-lane section, but there is no additional mobility benefit because the overall delay is the same. Therefore,

it is recommended to maintain the existing four-lane section from south of Old Blue Point Road to the north.

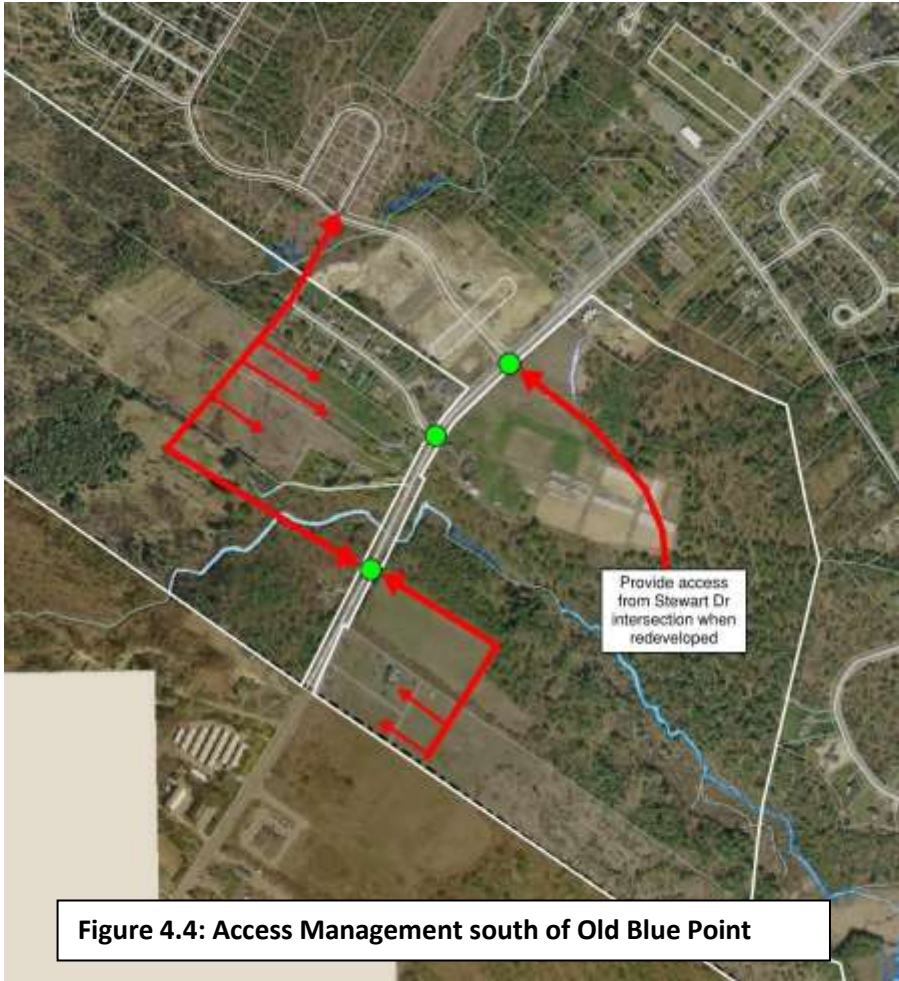
This section is prime for redevelopment in the near future. As redevelopment occurs, limit the number of access points directly onto Route 1. Stewart Drive is being constructed as part of the Dunstan Village development. This drive has potential to serve as a key access point to Route 1. Monitor this intersection for a traffic signal as volumes increase. **Figure 4.4** shows the proposed redevelopment access in the segment.

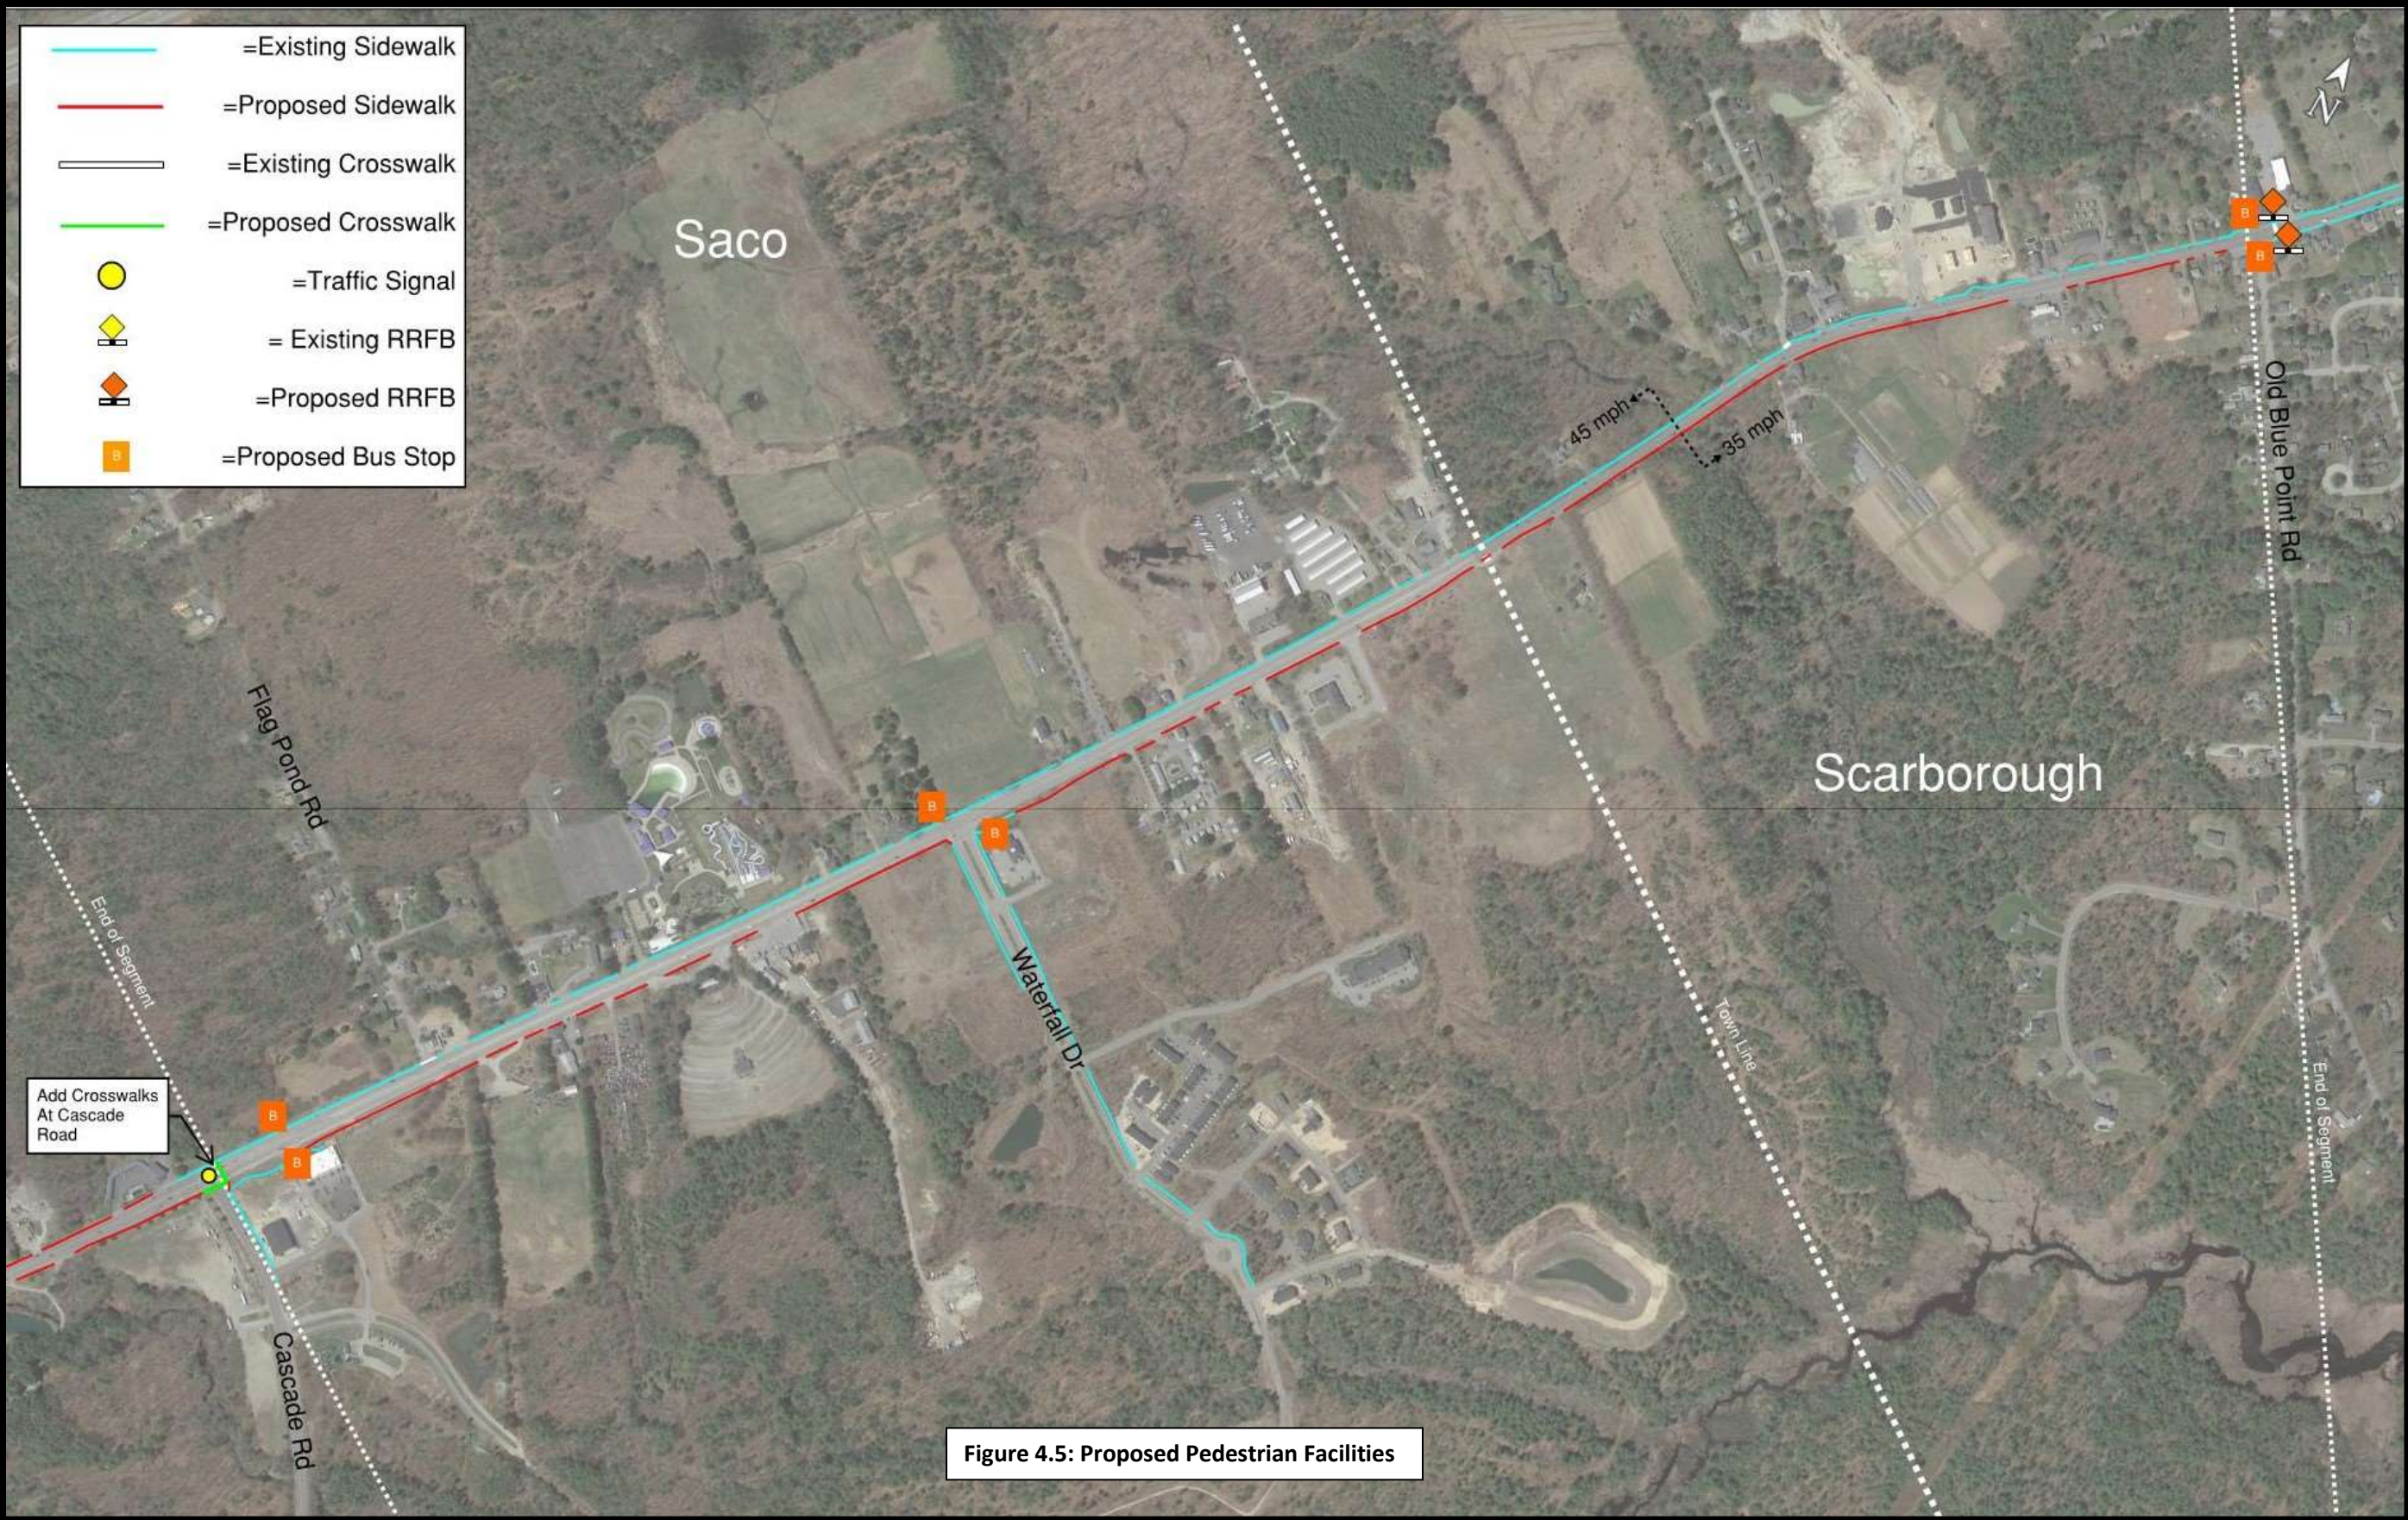
Figure 4.5: Proposed Pedestrian Facilities

Pedestrian facility recommendations are shown in **Figure 4.5**. Bicycle facility recommendations are shown in **Figure 4.6**.

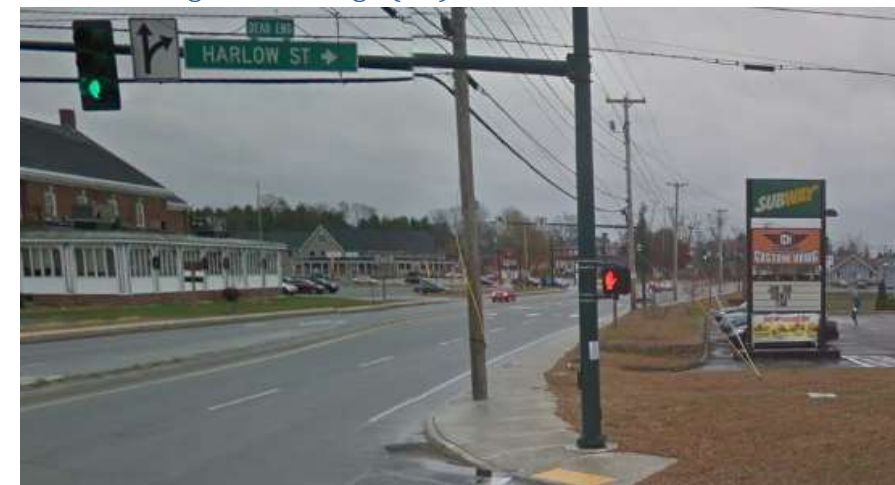
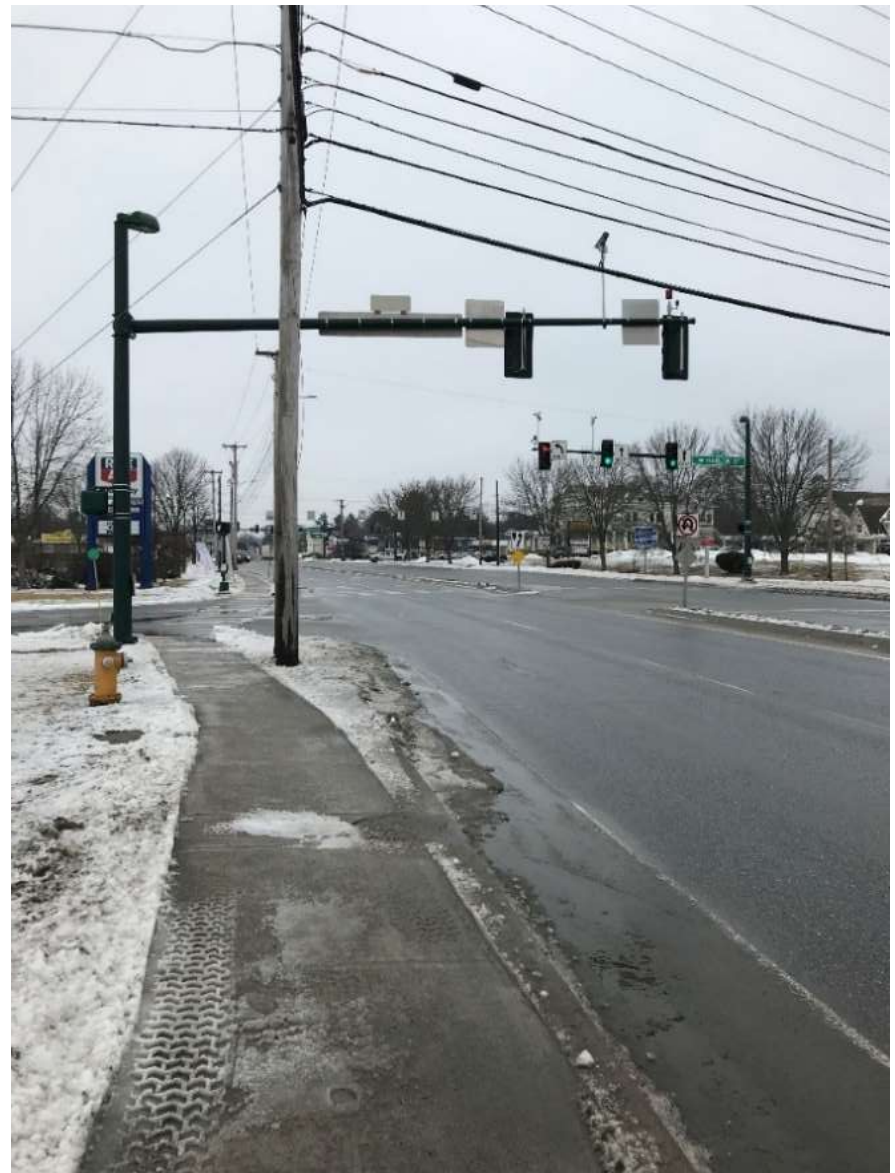
Dunstan Village Scarborough (NB)

The stop for Dunstan Village is a far-side stop just beyond the intersection of Harlow Street with Route 1. There is a narrow shoulder (approximately 2 feet wide) and the bus stops in the right lane. The concrete sidewalk is in good condition and is around 5 feet wide, 3 feet short of the space required for an ADA landing area, but steeper than permitted by ADA (a 4% slope was recorded in the field, which exceeds the 2% max for ADA compliance). The intersection is signalized with continental style crosswalks across each approach except for the northern leg across Route 1 abutting the bus stop. The curb ramps have Detectible Warning Panels and there are fully accessible signals with audible detection for all of the crosswalks. There is pedestrian scale lighting for the crossings located on the mast arm poles on the northwest and southeast corners of the intersection of Route 1 and Harlow Street. The stop lacks bus stop signage. Overall the stop could be rated as good. A southbound pair was not identified for this stop.
