DRAFT FINAL REPORT

SACO AND SCARBOROUGH ROUTE 1 CORRIDOR COMPLETE STREETS PLAN

June 4, 2019

prepared by:
TYLIN INTERNATIONAL

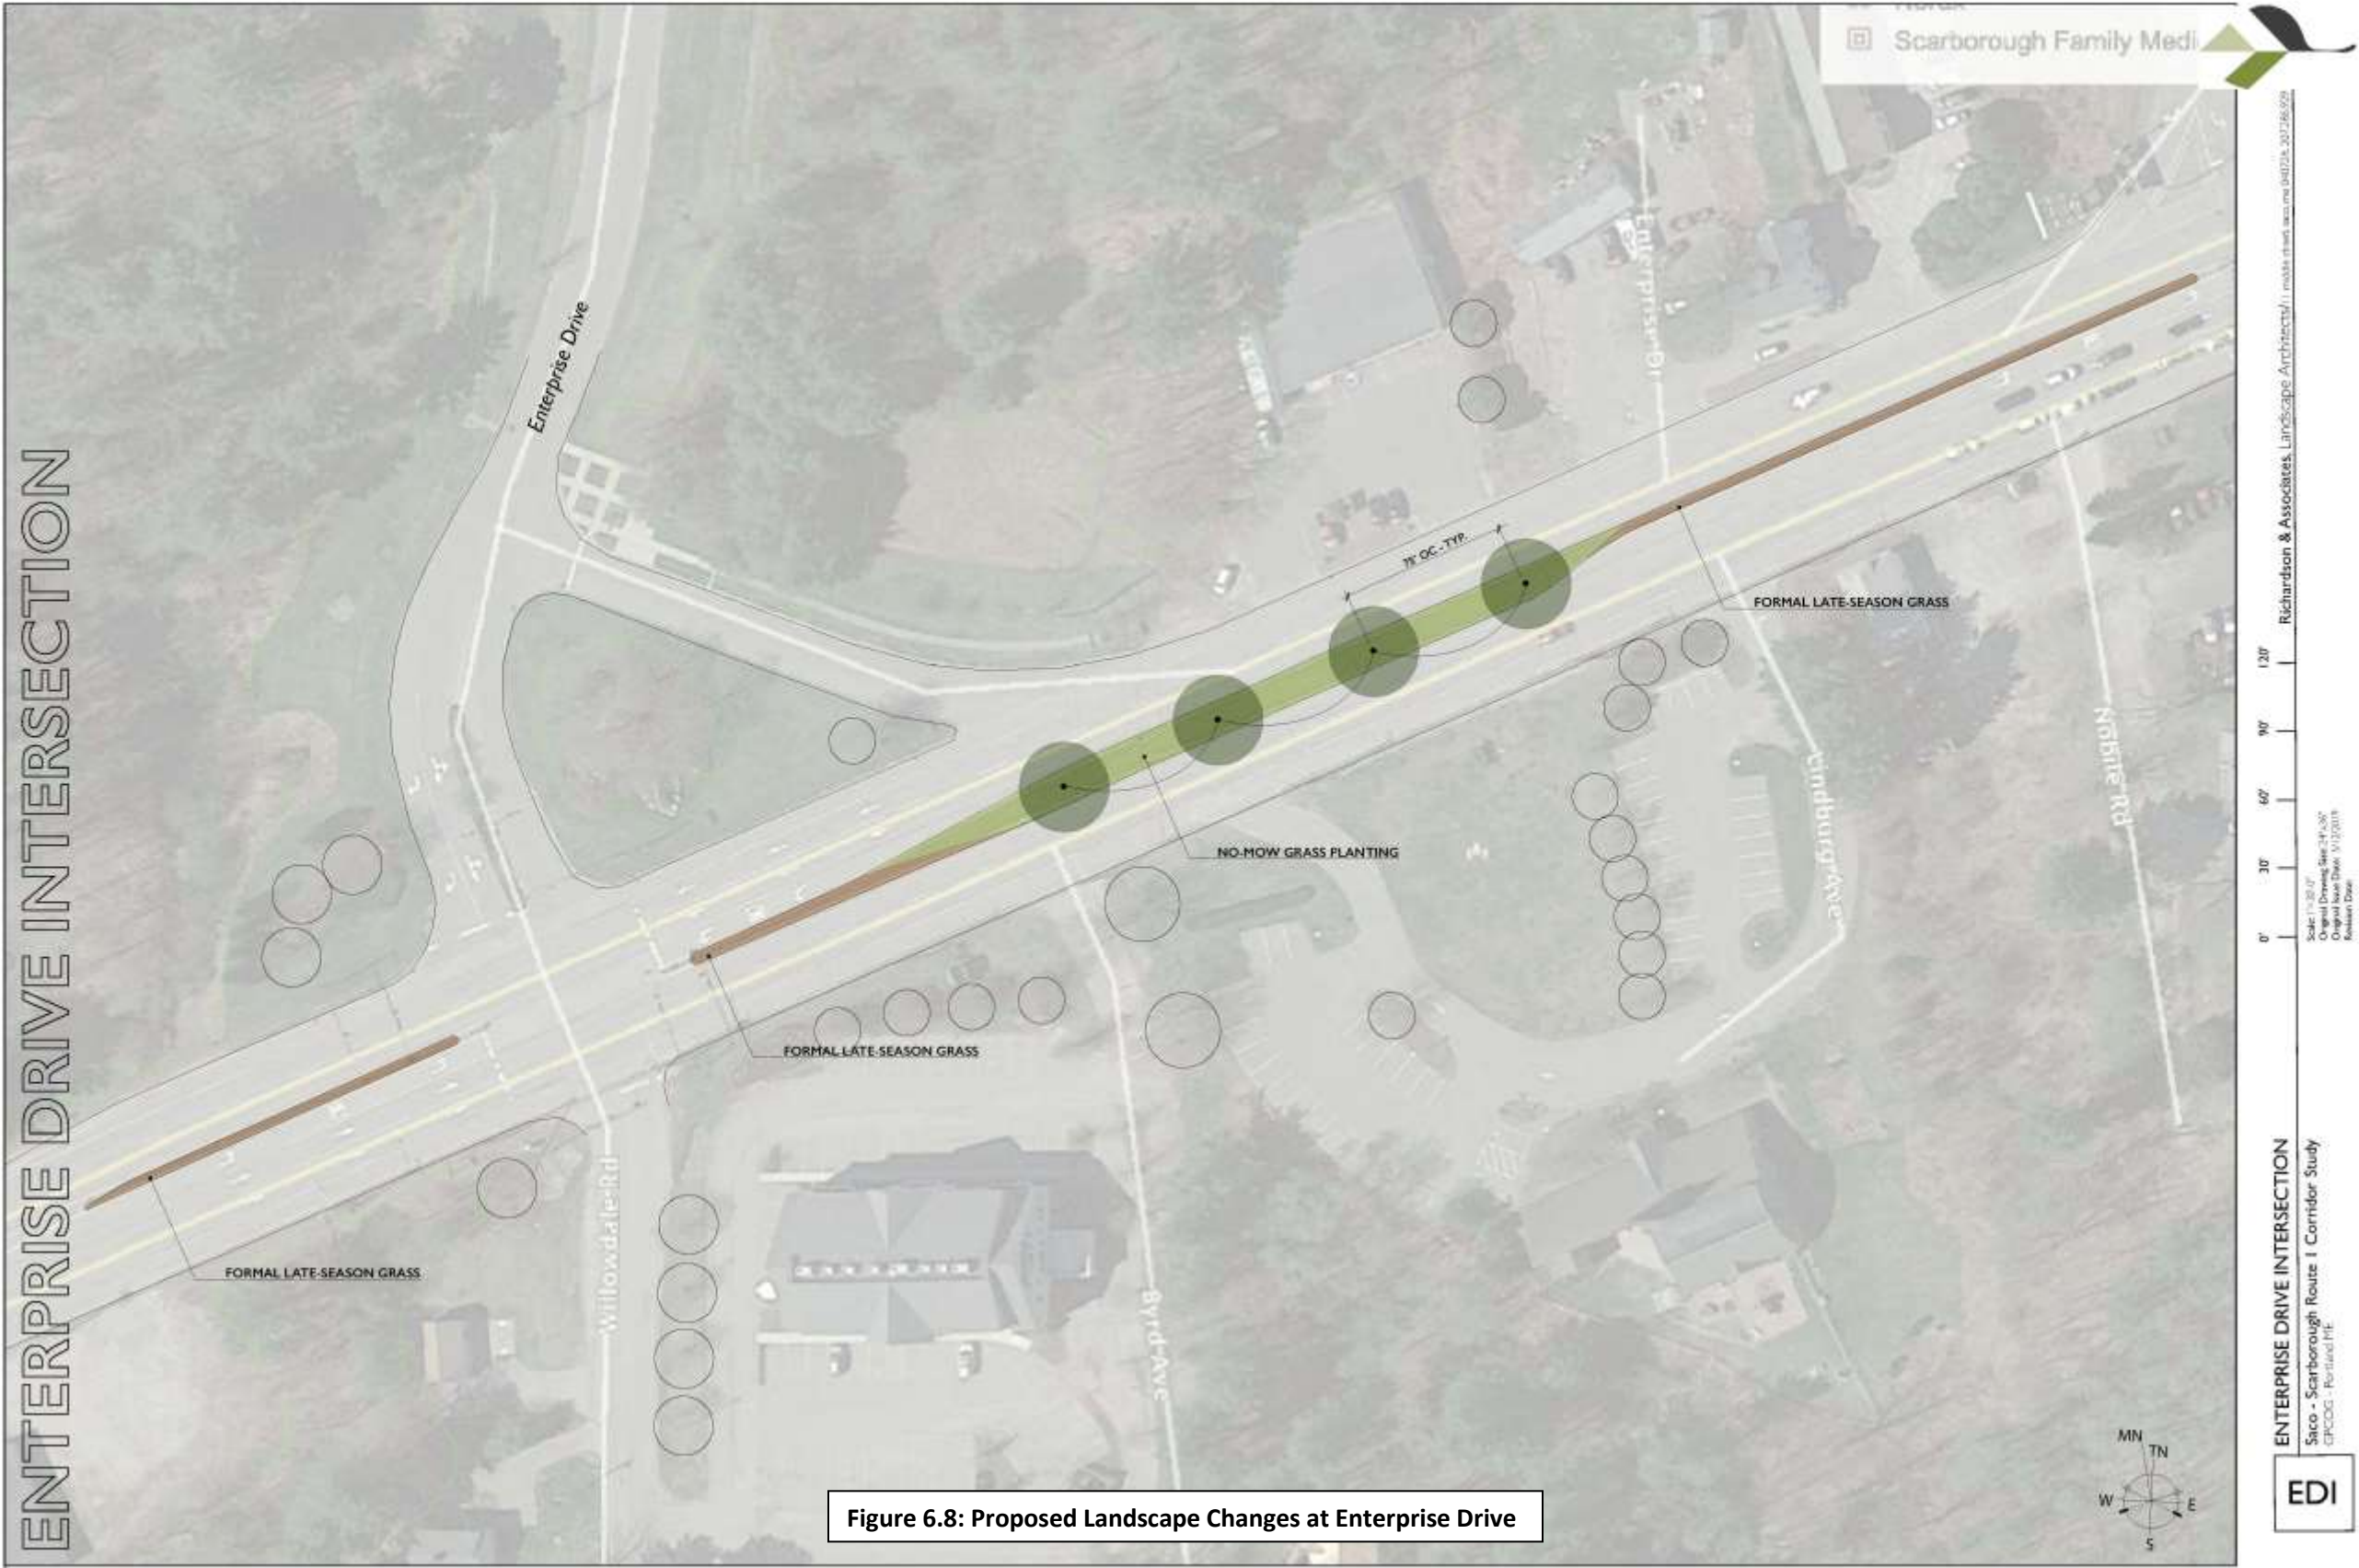
Figure 6.8: Proposed Landscape Changes at Enterprise Drive

Landscape recommendations for this area are aligned with previous design efforts; integrate green infrastructure where possible and introduce a tree/vegetation canopy that visually reduces the scale of the multi-lane vehicular corridor. Recommendations are shown in **Figure 6.8**.

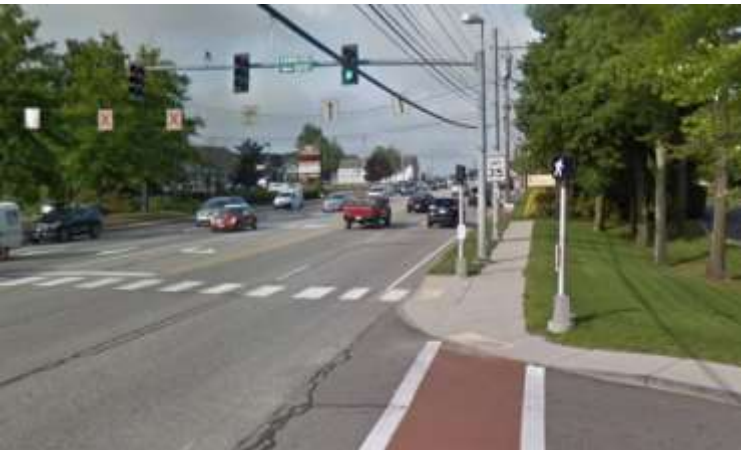
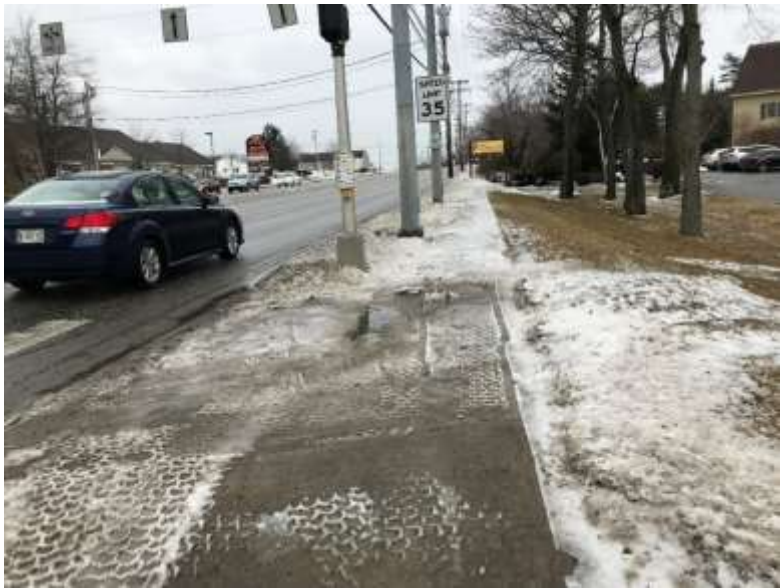
Route 1 Hannaford Drive Cheese Iron (NB)

The stop for the Hannaford Drive Cheese Iron is a far-side stop just beyond the intersection with Hannaford Drive. There is a narrow shoulder (approximately 1-foot wide) and the bus stops in the right lane. This stop is marked with a bus stop sign. The sidewalk appears to be in reasonable condition; however, it ends just after the bus stop. There is a grass strip along the curb and some pinch points created by utility poles. The intersection is signalized with continental style crosswalks across each approach except for the eastern leg which has a brick crosswalk. The curb ramps on the east side of Route 1 have DWP; however, DWP are missing from the west side curb ramps. There are fully accessible signals with audible detection for all of the crosswalks. There is street lighting at all four corners of the intersection of Hannaford Drive. Overall the stop could be rated as fair.

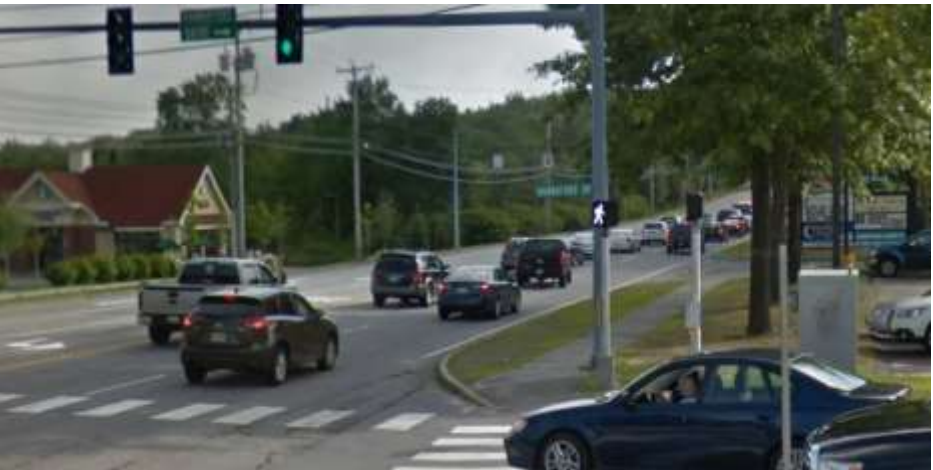
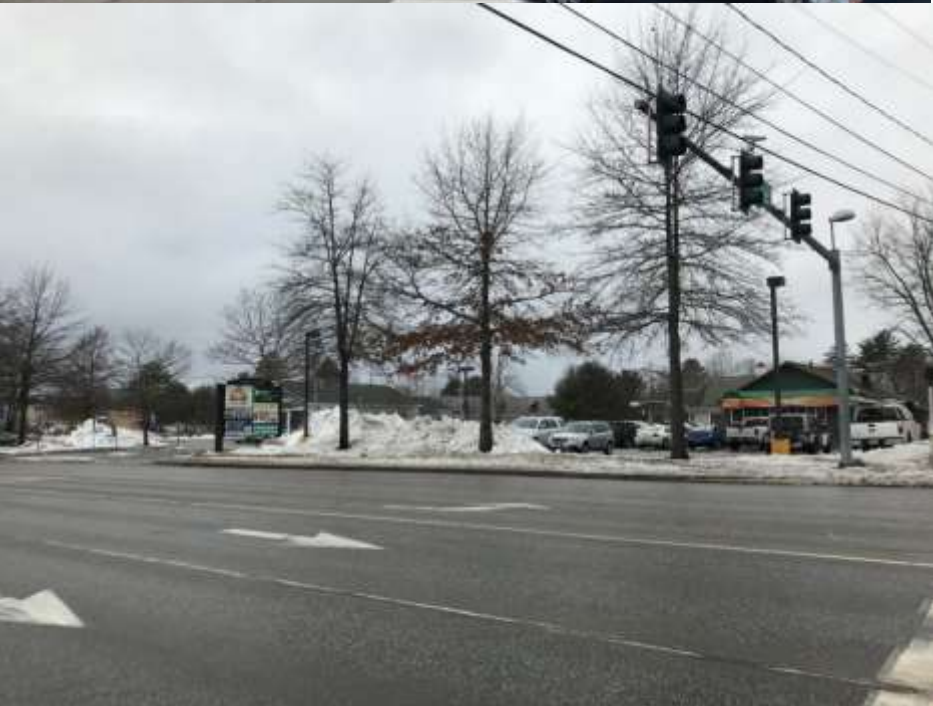
Hannaford-Jordan Florist (SB)

The stop for Hannaford-Jordan Florist is a far-side stop just beyond the intersection with Hannaford Drive. There is a narrow shoulder (approximately 1-foot wide) and the bus stops in the right lane. The sidewalk appears to be in reasonable condition. Although there is a grass strip between the curb and the sidewalk; therefore, lacking an ADA level landing area. See the northbound pair for overall description of intersection elements. The stop lacks bus stop signage. Overall the stop could be rated as fair.

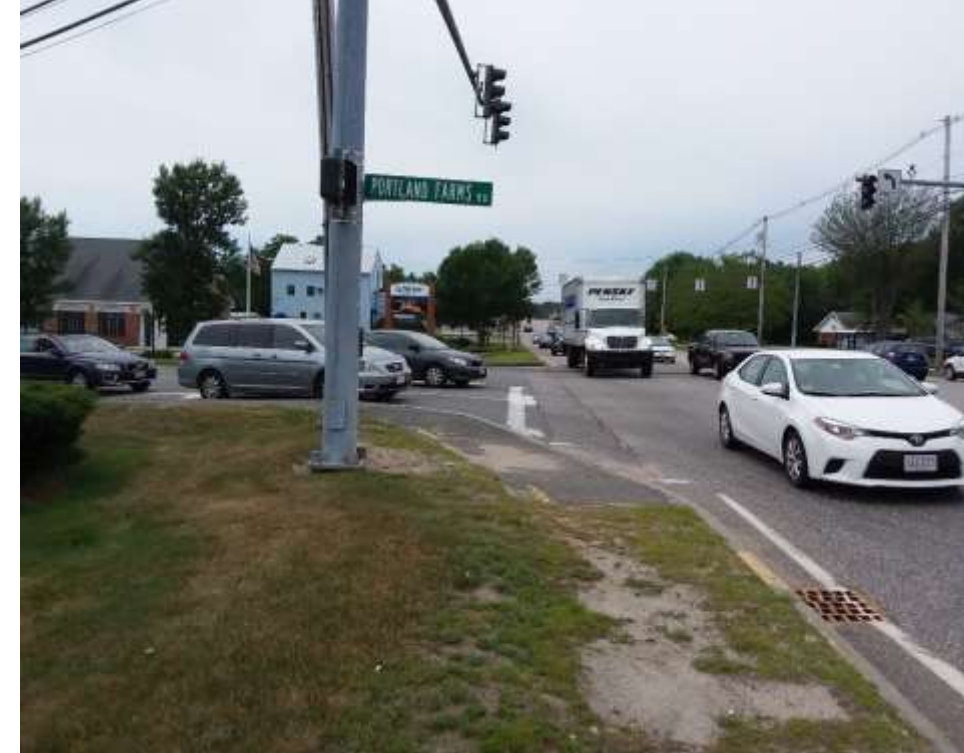
Martin’s Point Health Care (NB)

The northbound stop is also located in the right lane and lacks any good bus stop design feature, even at the most basic level. There is no sidewalk, or landing area, and thereby no sidewalk connection to the crosswalk, and lacks any amenities. The grass area where riders are forced to board and alight at has a grade change close to the road, providing a rather precarious area for riders, as well as other pedestrians needing to utilize this path. Furthermore, it lacks any defining feature, even a standard bus stop sign, that designates this as a bus stop. The only positive feature of this stop is its connection to a signalized crosswalk with some form of ramp to/from the crosswalk; and therefore, would most likely be rated as a very poor bus stop.

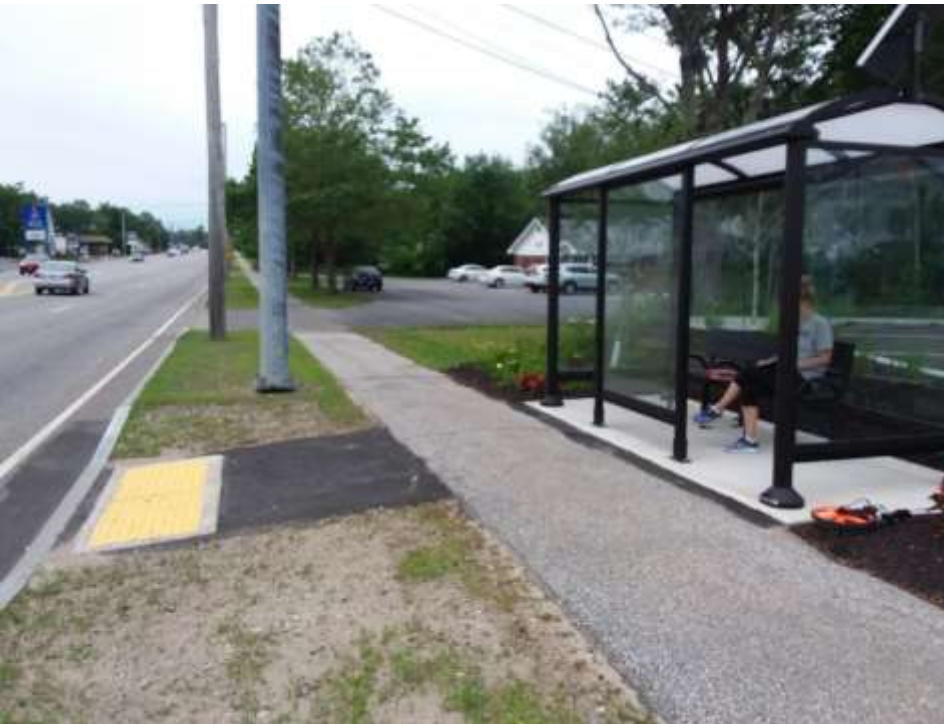
Martin’s Point Health Care (SB)

The southbound stop is located directly outside of Martin’s Point Healthcare and the bus stops in the right lane. It is well sited, as close as possible to Martin’s Point, while maintaining safety and traffic operations at the intersection. The asphalt sidewalk is in reasonable condition. The stop is connected to an intersection with crosswalks on two sides, both signalized - one across Route 1 and the other across Martin’s Point driveway/access road. Interestingly the standard crosswalk style markings on Route 1 are less prominent (and faded) than the driveway crosswalk, where the continental style was applied. Also, it is not an APS, nor is there an audible function. There are curb ramps with DWP across Martin’s Point driveway, but crossing Route 1, although there are curb cuts or ramps, there is no DWP and they do not meet the ADA requirements. It has a shelter for customers, which helps to define this location as a bus stop, although a covered accessible space within the shelter is not provided. There is an asphalt paved area at the boarding area, but it was constructed as a curb ramp rather than a level landing area as required by the American’s with Disabilities Act. A clear zone for the back door is provided. Overall the stop could be rated as good.

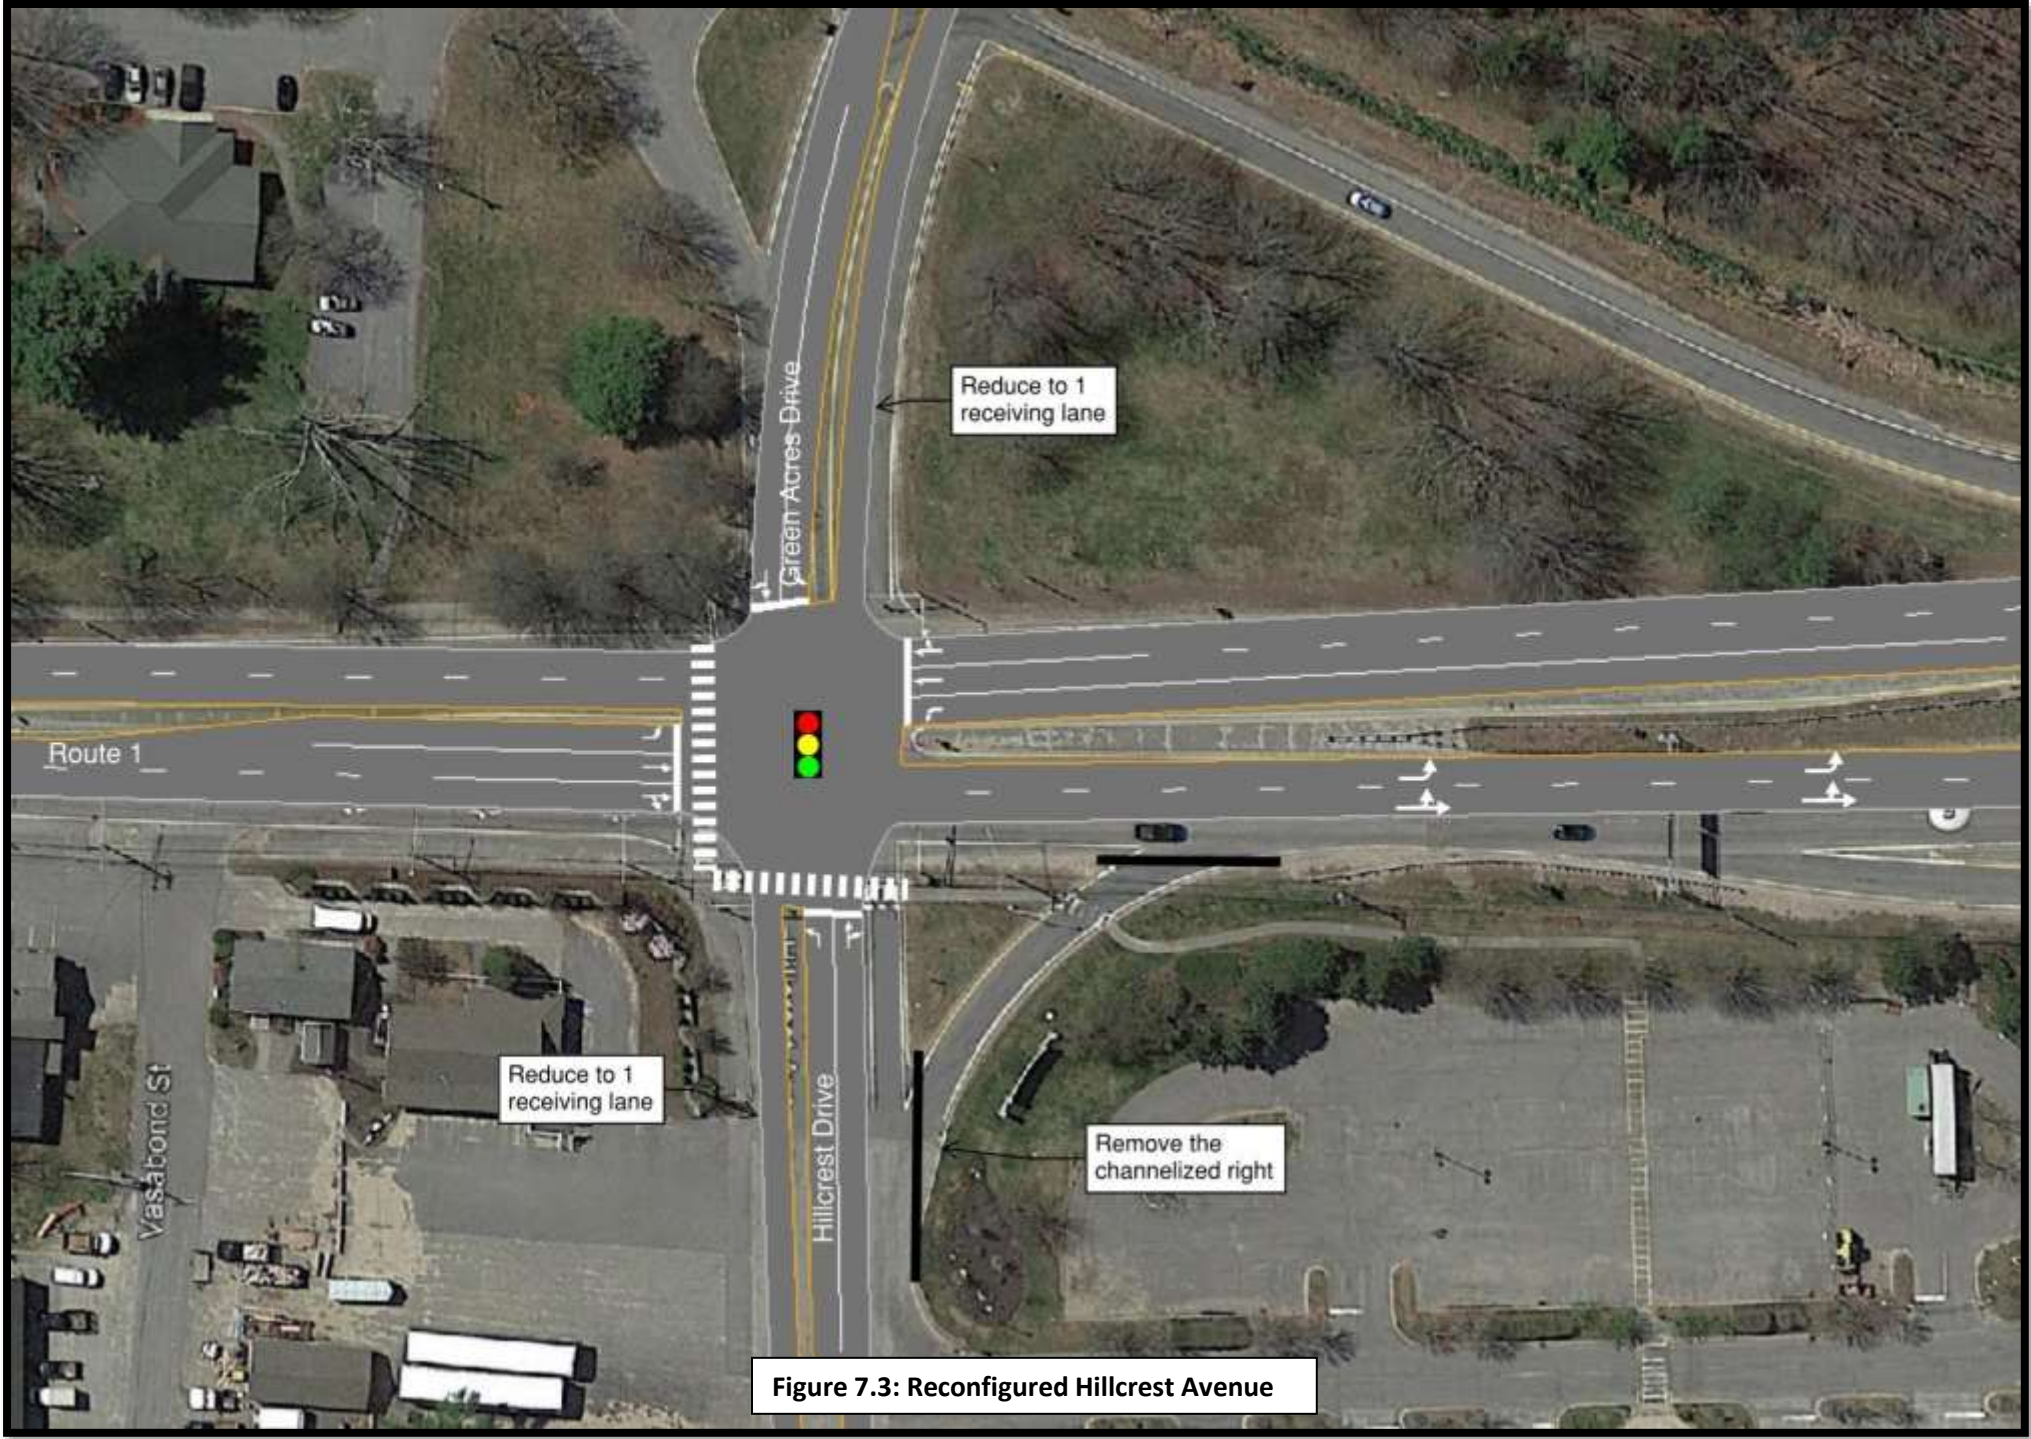
Figure 7.3: Reconfigured Hillcrest Avenue

It should be noted that the reconfigured intersection requires changes at the Route 1/Scarborough Connector Diverge to the north. As depicted on **Figure 7.3**, only two lanes depart the signalized intersection, where three lanes currently do now. This change is currently being modeled to determine feasibility. As an alternative, we developed a concept (see **Figure 7.4**) that maintains Route 1 capacity and thus the three lanes approaching the Connector.

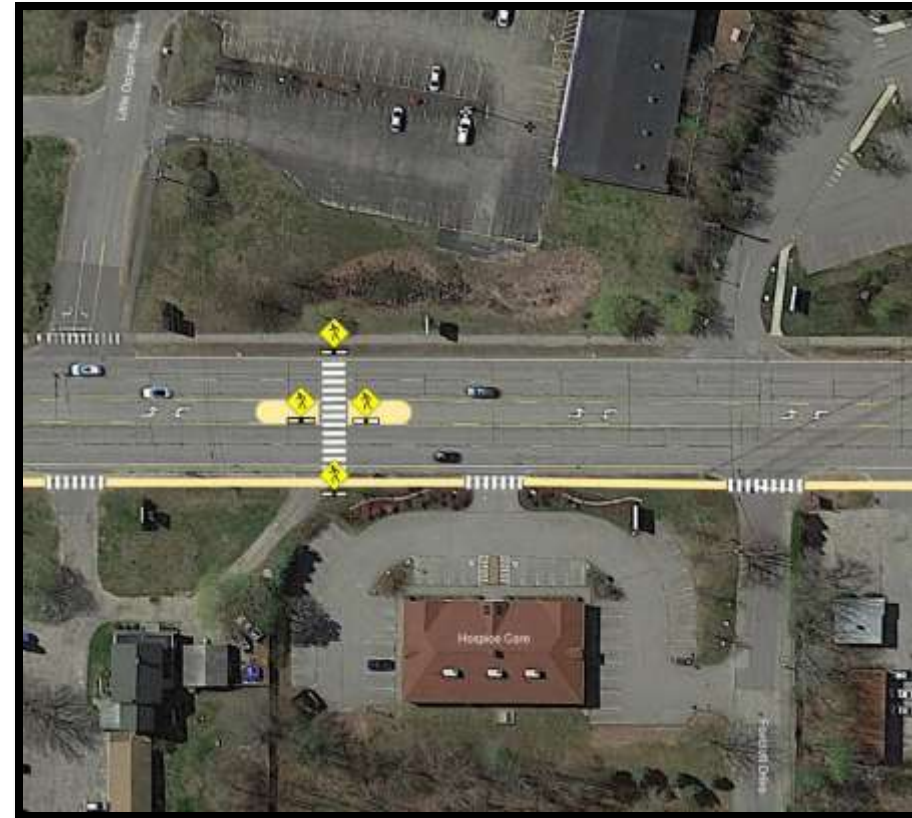
There is an interest in adding a crossing somewhere in the area of Little Dolphin Drive and Foxcroft Drive. The distance to either signalized crossings at Hannaford Drive or Portland Farms Road is too far and thus pedestrians attempt to cross in this area. The potential crossing likely does not meet warrants for a PHB. An RRFB paired with a median island is suggested at the location noted in the following graphic.

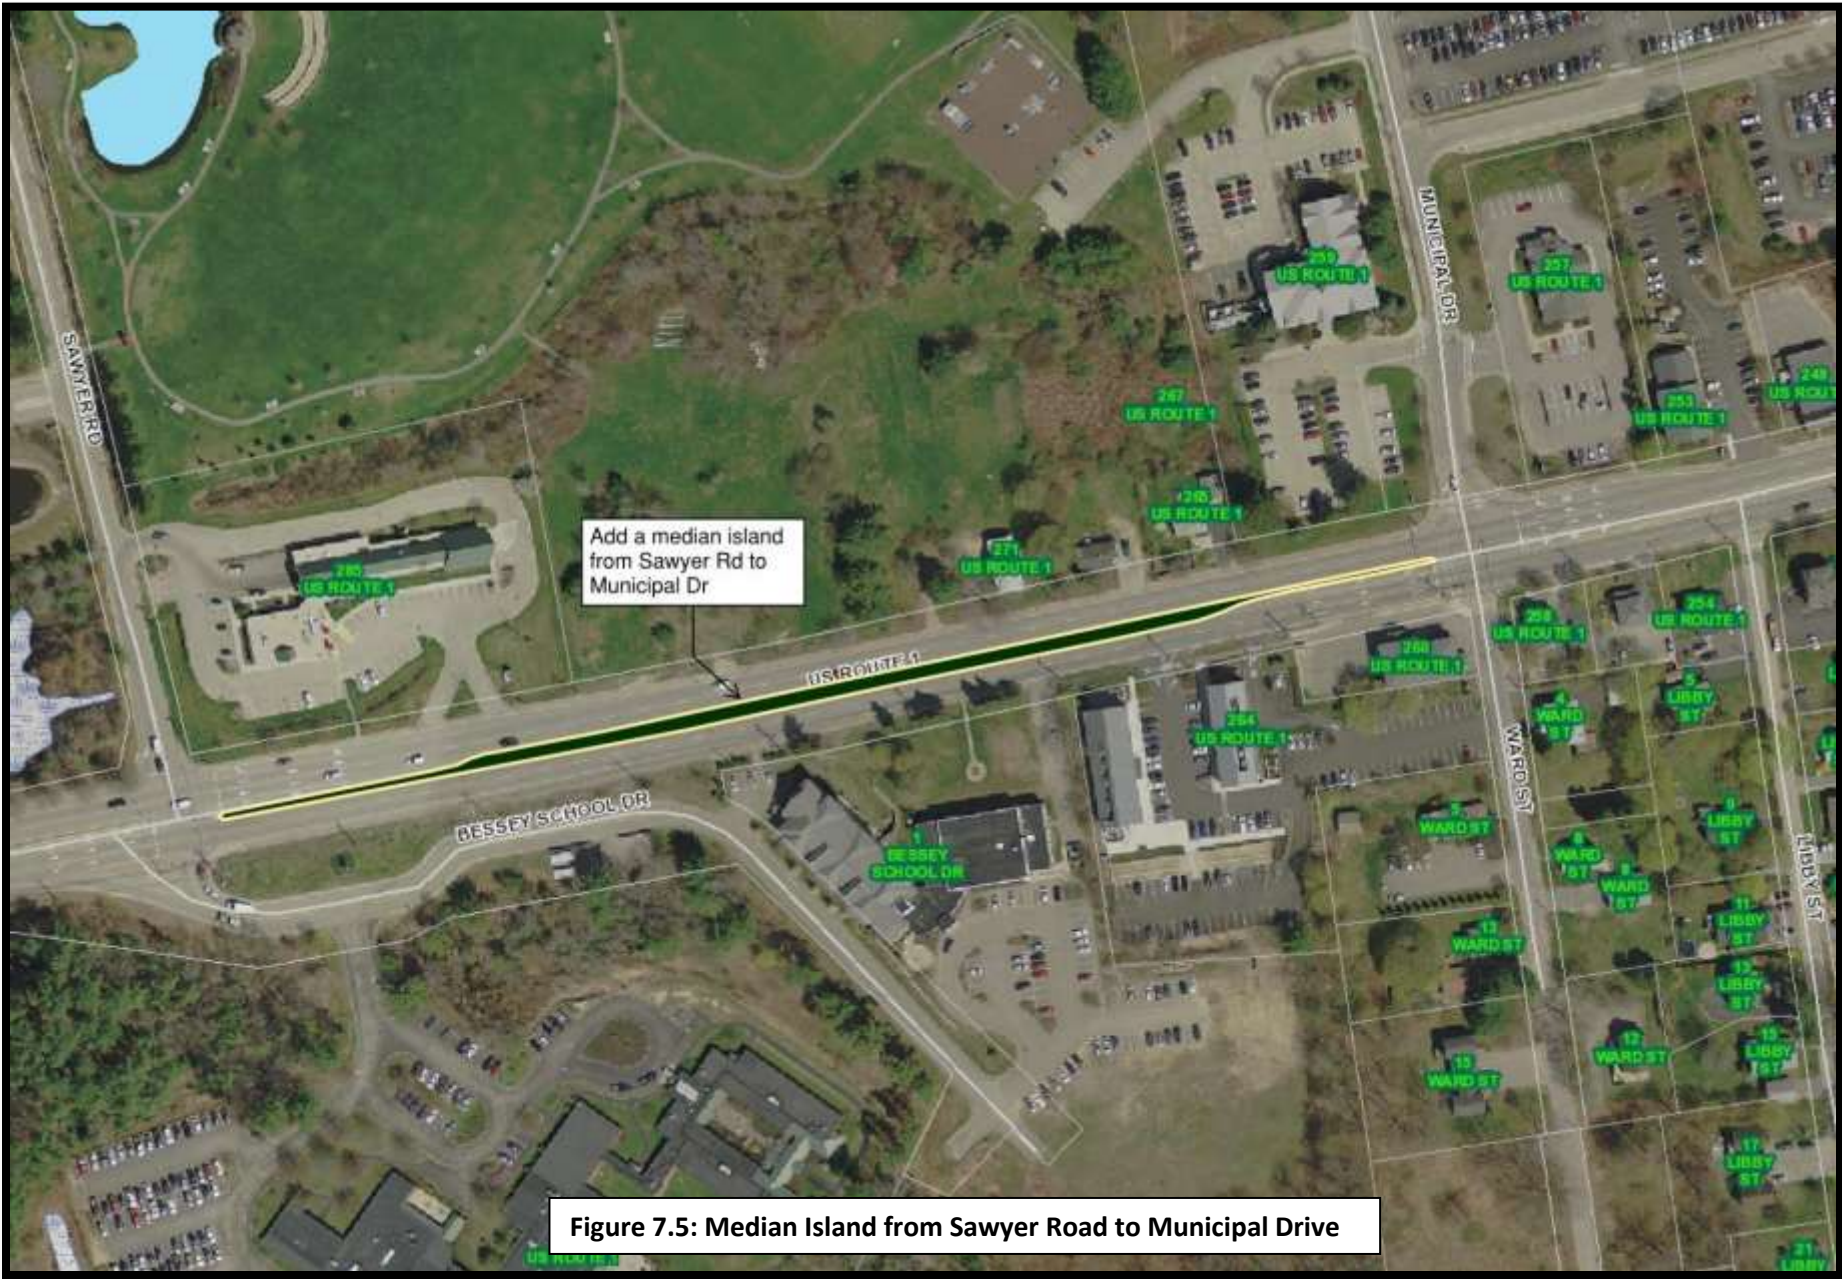
Figure 7.5: Median Island from Sawyer Road to Municipal Drive

The median islands proposed from Sawyer Road to Hannaford Drive will eliminate left-turning movements. Eliminating these movements will improve mobility and safety through the segment. Inter-parcel connections and frontage roads should be provided in conjunction with the median. **Figures 7.5 through 7.7** depict the median islands.

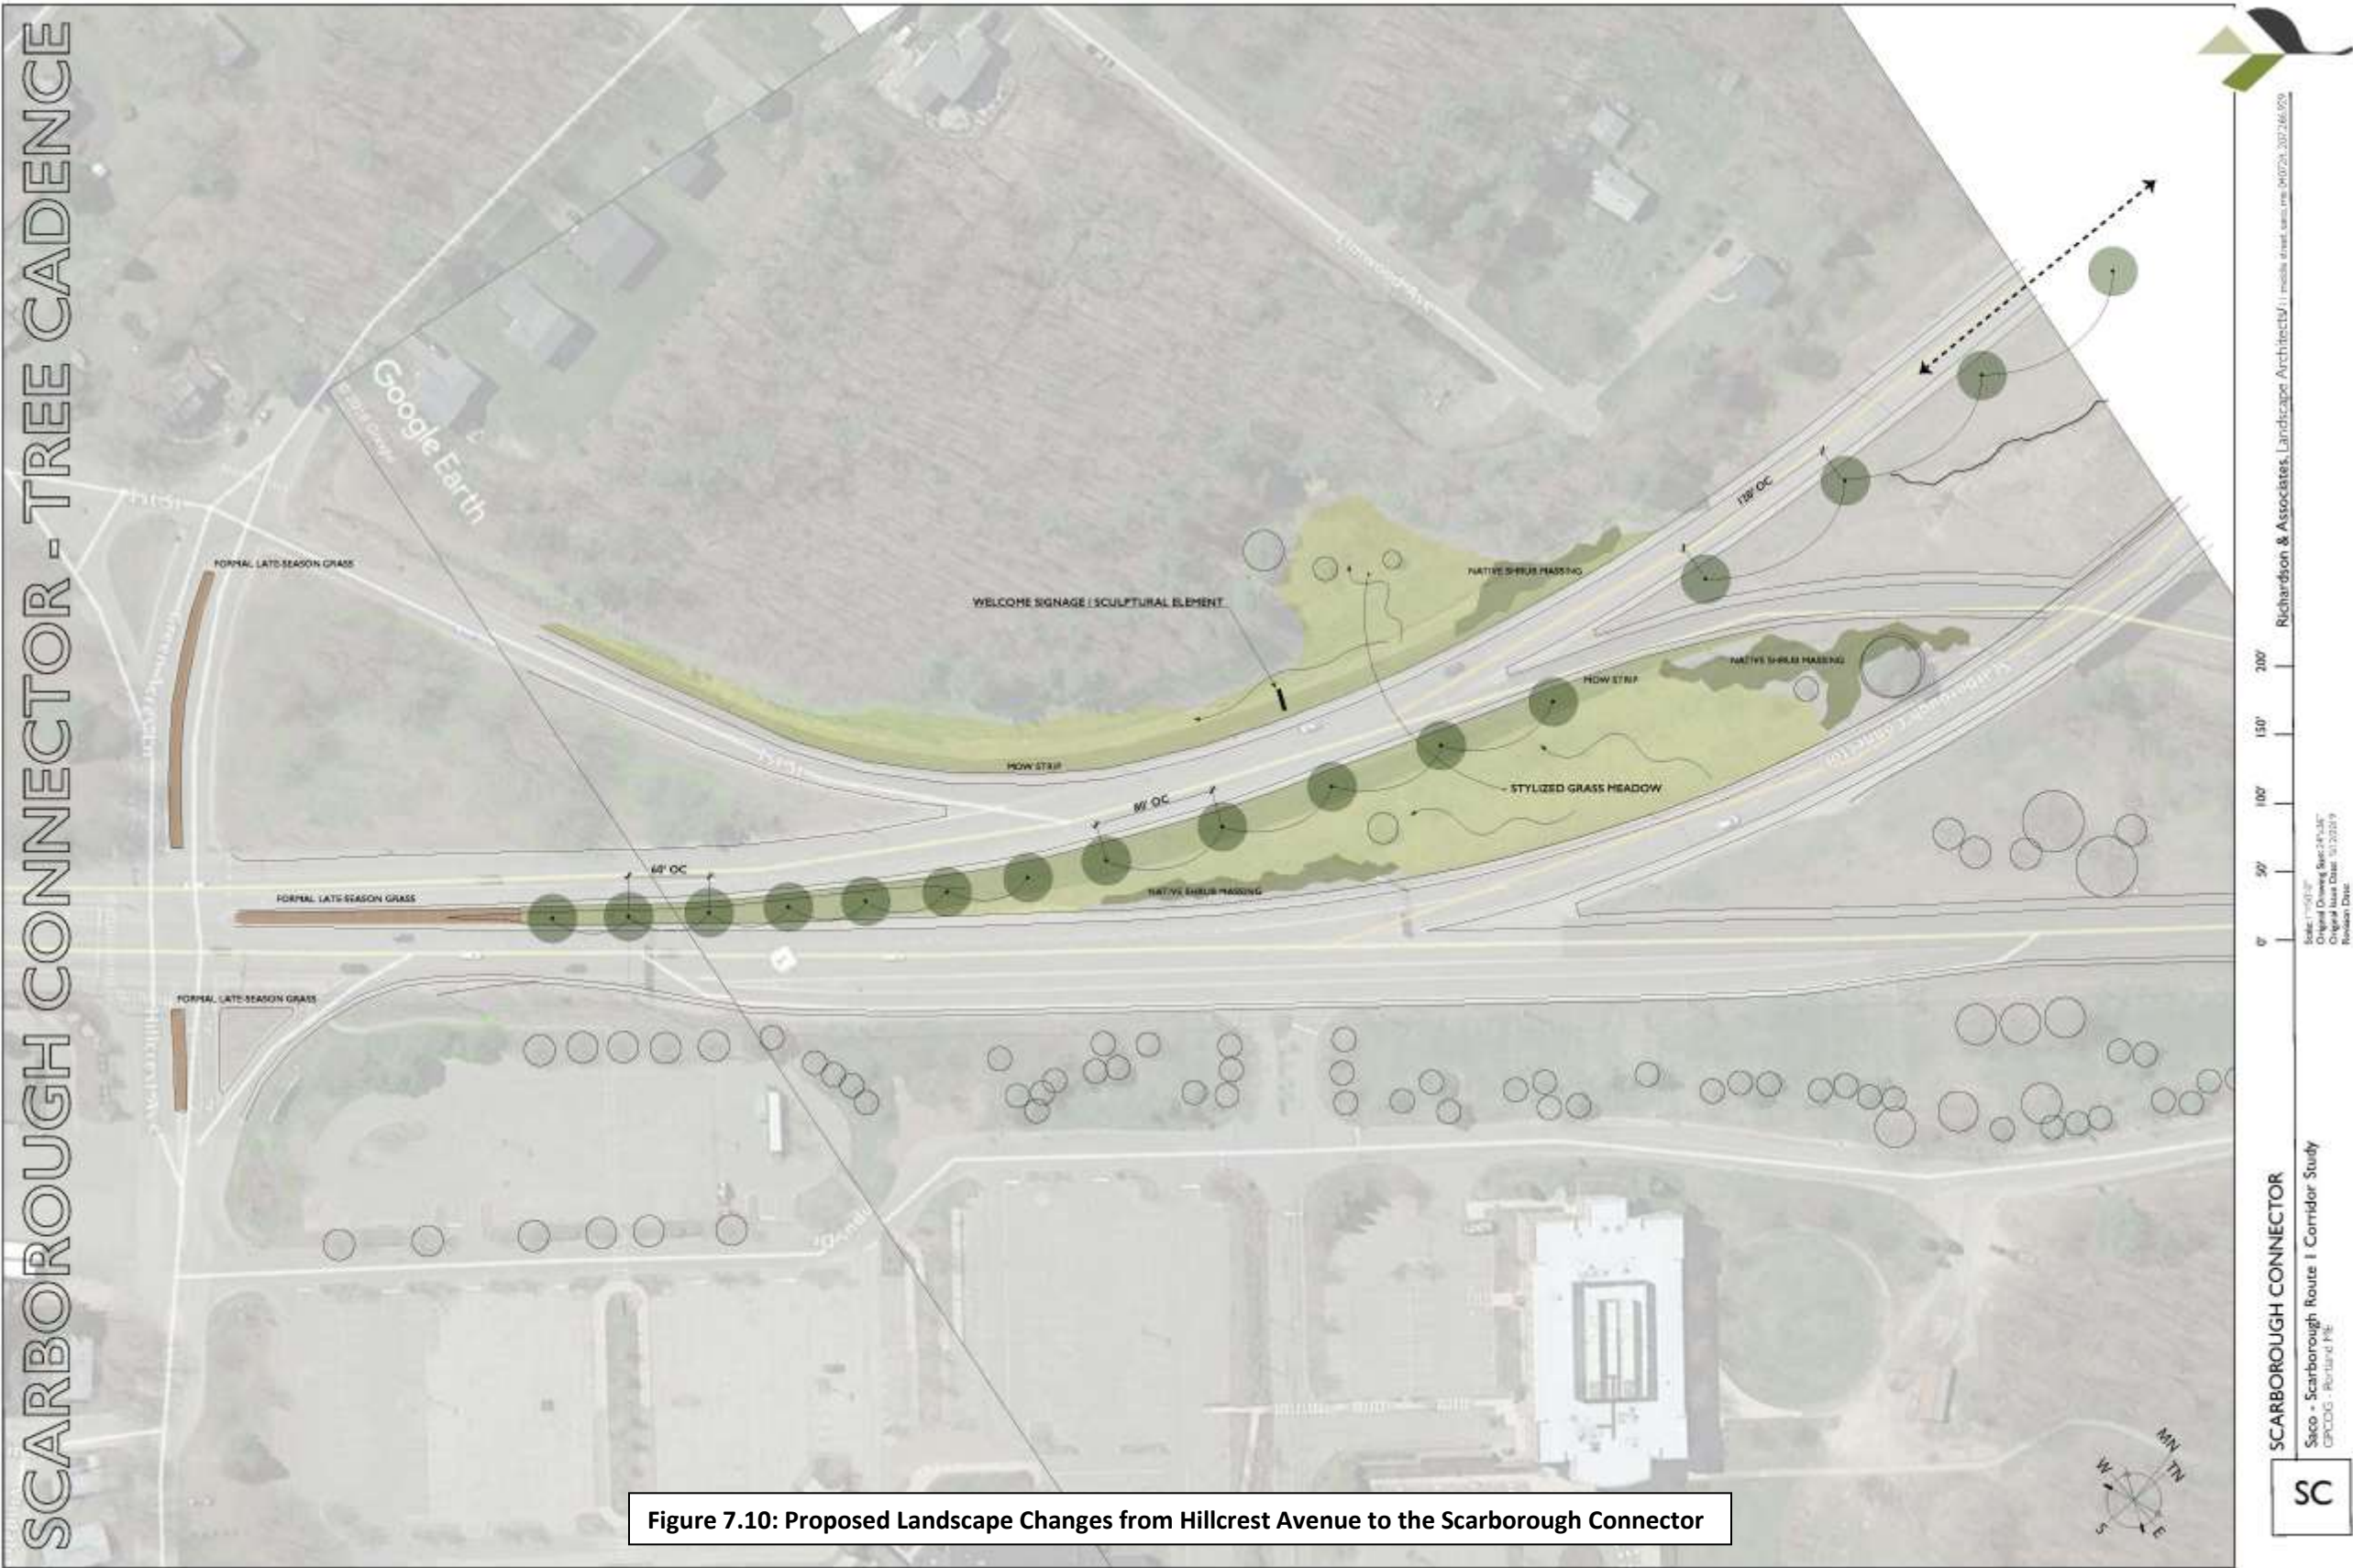
Figure 7.10: Proposed Landscape Changes from Hillcrest Avenue to the Scarborough Connector

1. Sculpture(s) and/or Signage
2. Lighting - Street and Landscape

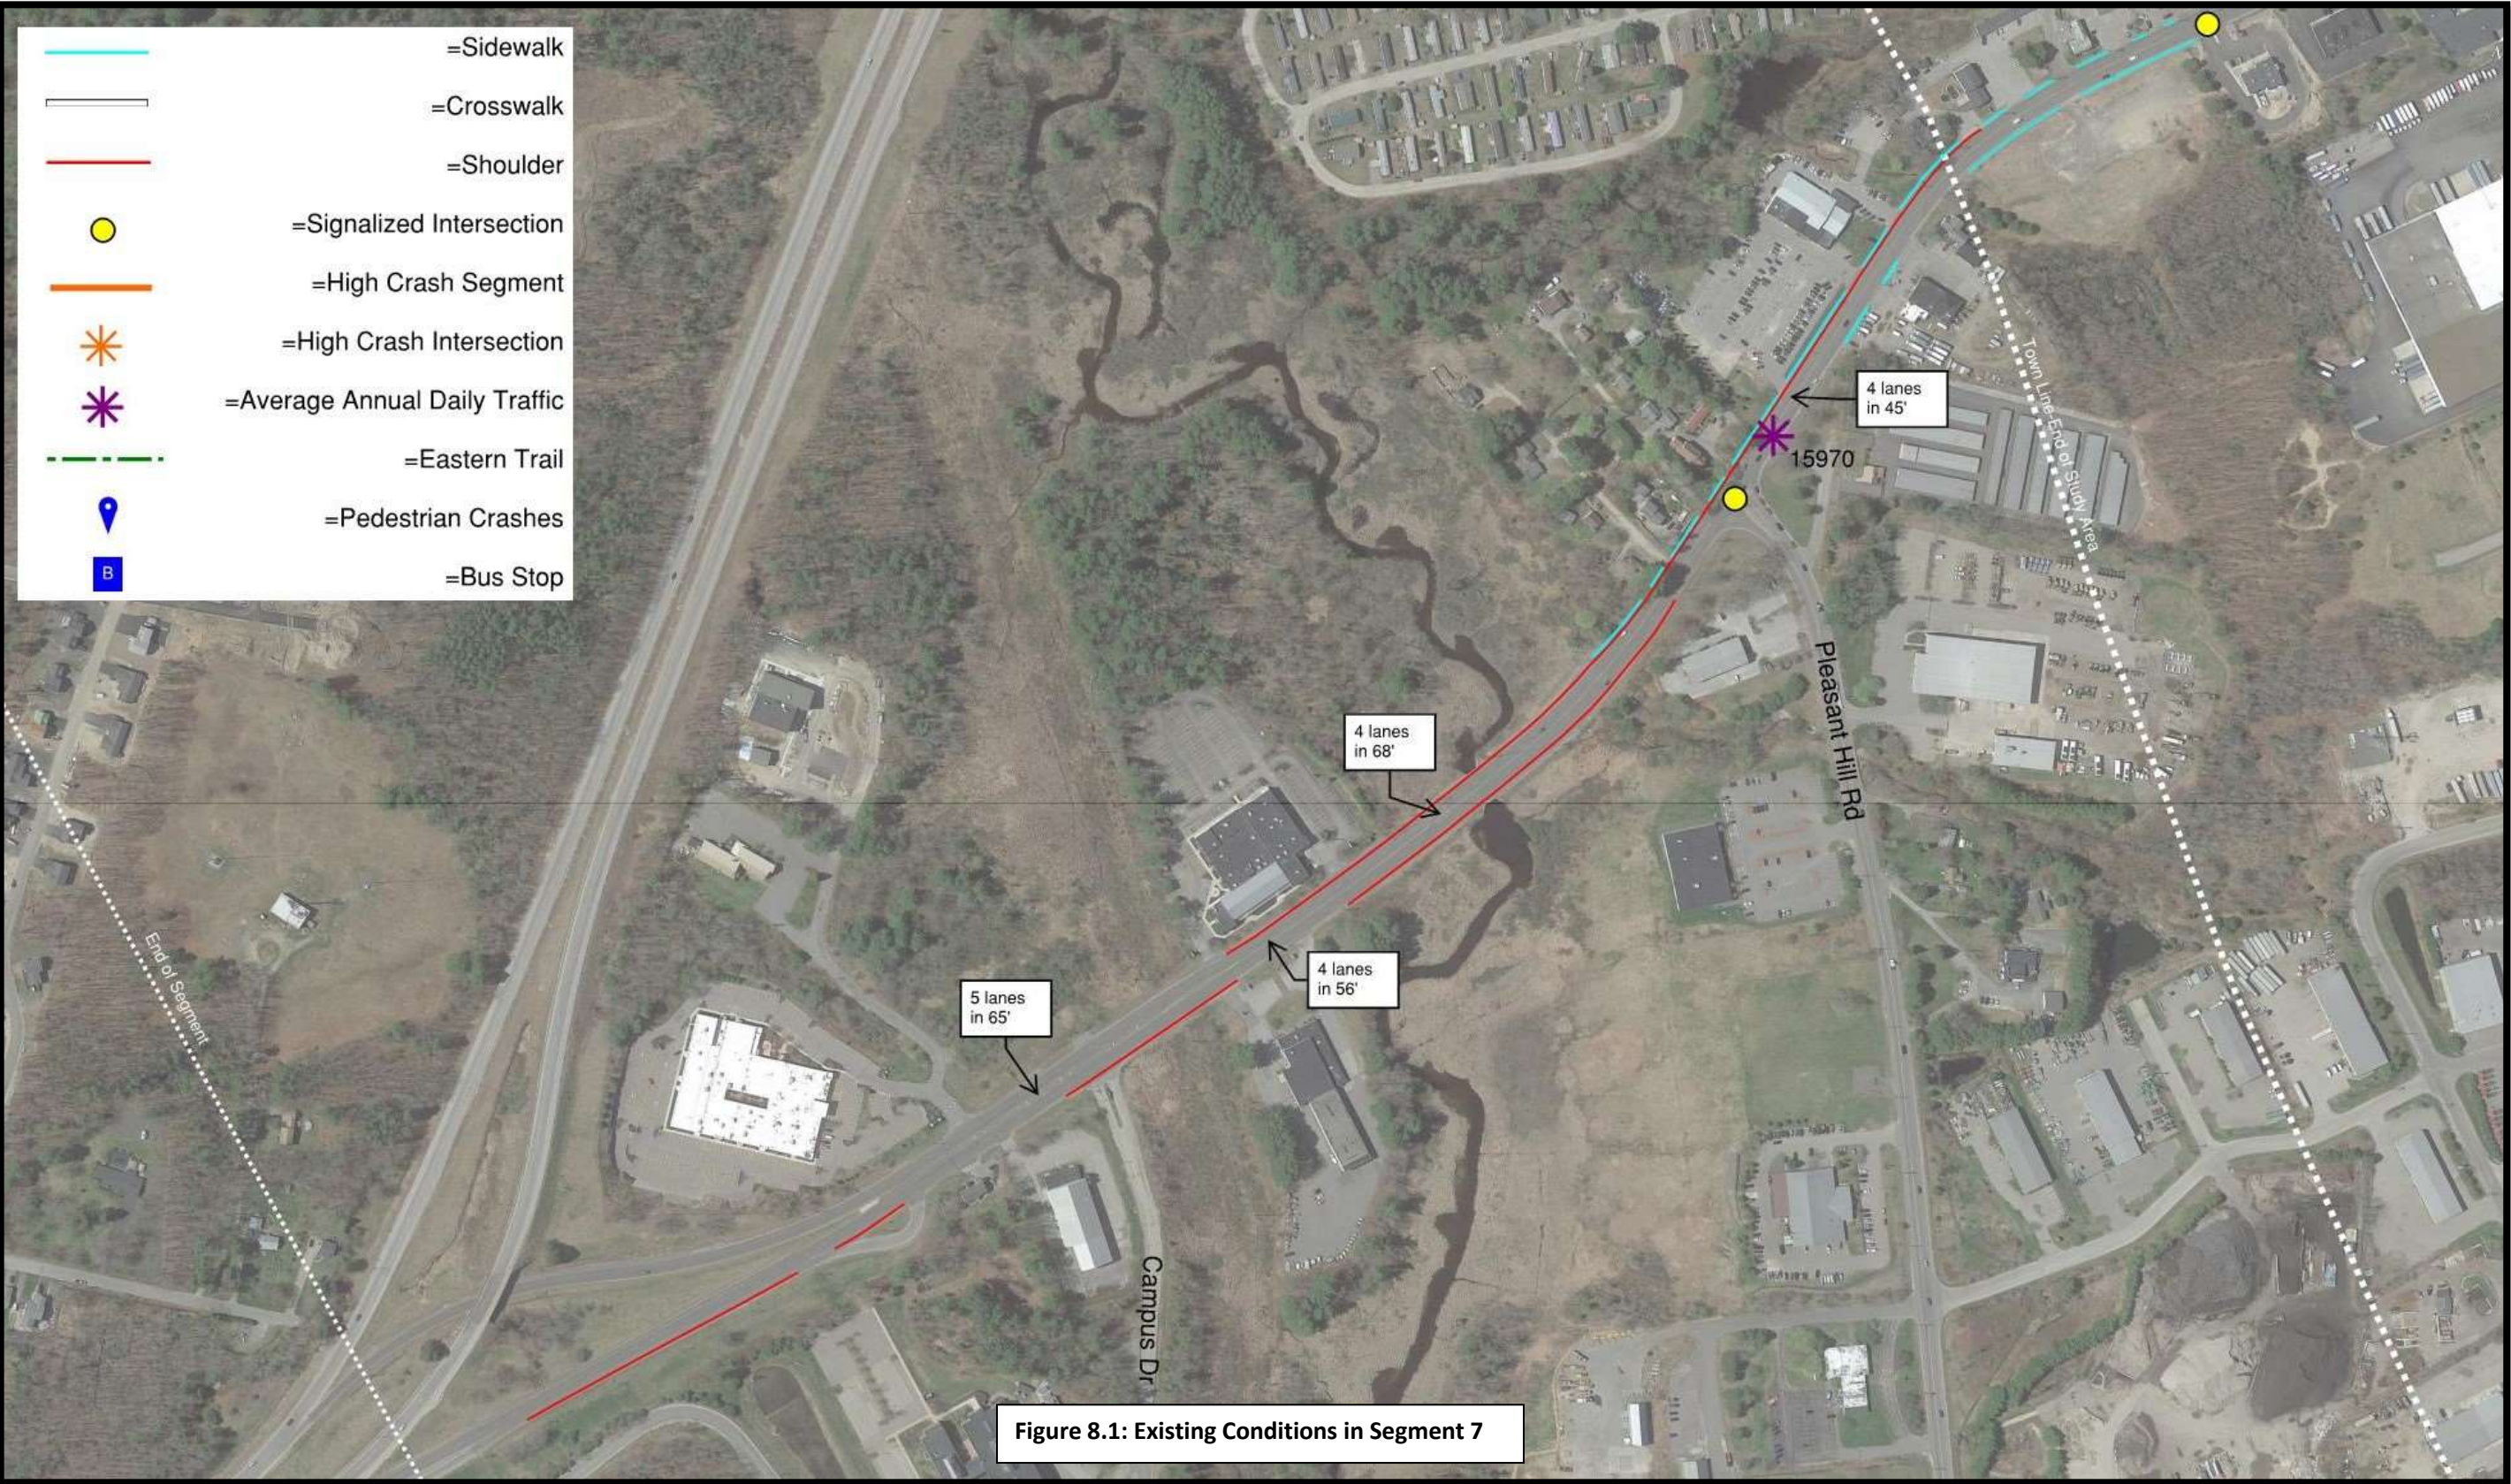
Figure 8.1: Existing Conditions in Segment 7

Sidewalks and crosswalk locations are shown in **Figure 8.1**. There are sidewalks on the north side of the road from the town line to just south of Kenosha Lane. There are no formal places to cross Route 1 in this segment. The shoulders only exist over the Nonesuch River. The Scarborough Connector separates the segment.

Figure 8.1 depicts the existing transportation information for Route 1 in the segment. Some noteworthy details include:

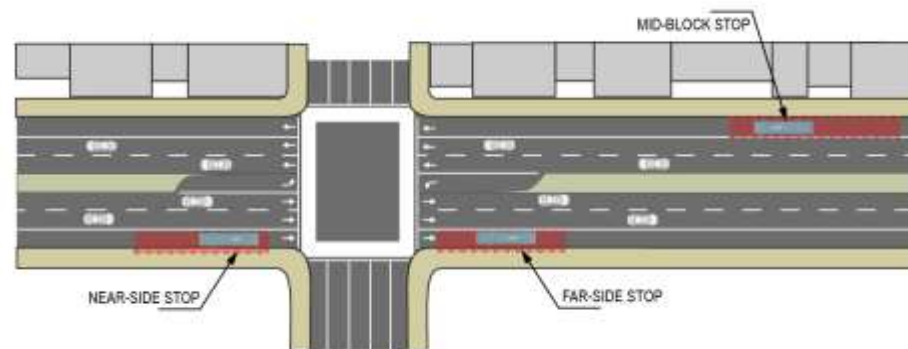
There are 3 general placement options for bus stops along a roadway, as depicted in the image above:

1. Near-side: located before an intersection crossing.
2. Far-side: located after an intersection crossing.
3. Mid-block: located in between two intersections.

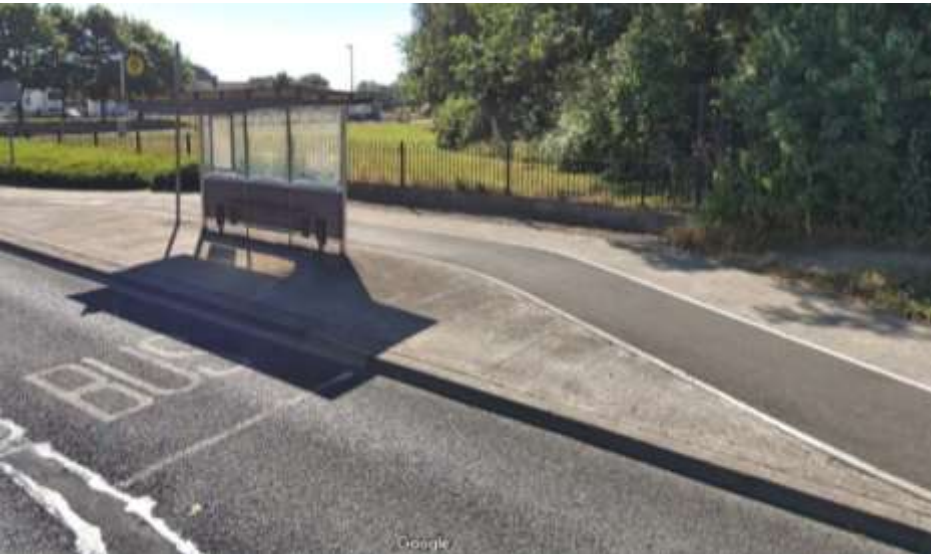
When constructing a bus stop adjacent to a sidewalk level bike lane or shared or multi-use path, the bike lane/path should be diverted behind the bus stop, to minimize conflicts between bus riders, and bicycle riders, to create a bus island (also referred to as a floating bus stop or bus stop bypass). See image below for an illustration of this configuration.
