DRAFT FINAL REPORT

SACO AND SCARBOROUGH ROUTE 1 CORRIDOR COMPLETE STREETS PLAN

June 4, 2019

prepared by:
TYLIN INTERNATIONAL

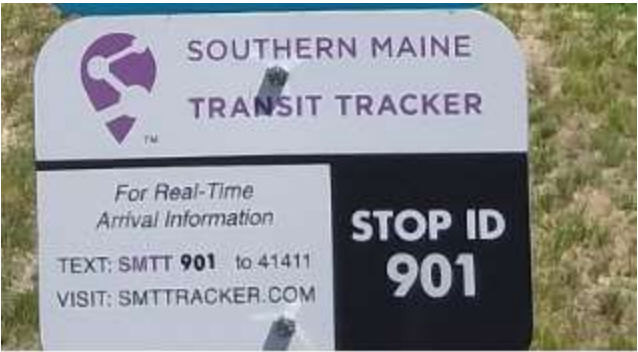
Signs serve as a source of information to customers and bus drivers regarding the location of the bus stop, can function as a reference point for the landing area and are an inexpensive and obvious marketing tool to promote transit use. The bus stop can be the customer’s initial point of access to the system and as such should inform customers that they are at the correct location to catch a specific route in a specific direction. Bus stop customer information may include route information, system and neighborhood maps, wayfinding information, and schedules (real-time or hard copy display, such as the Southern Maine Transit Tracker shown below), and general service information.

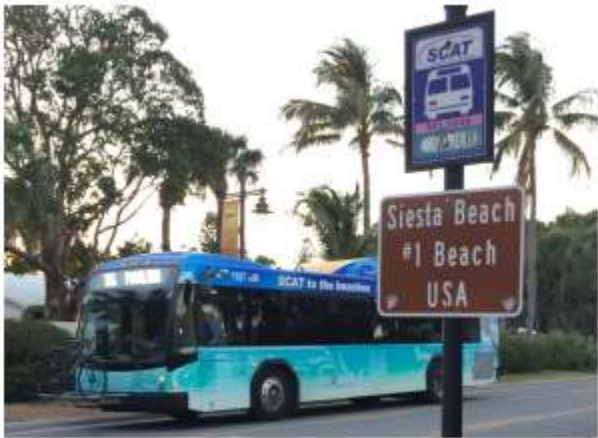
Bus stop signs may be considered for framing to coordinate with other street furniture and provide more context sensitivity in historic or beautified neighborhoods and downtown areas as depicted in the image below. Bus stop signs should be retroreflective to increase visibility for bus drivers and customers in the dark.

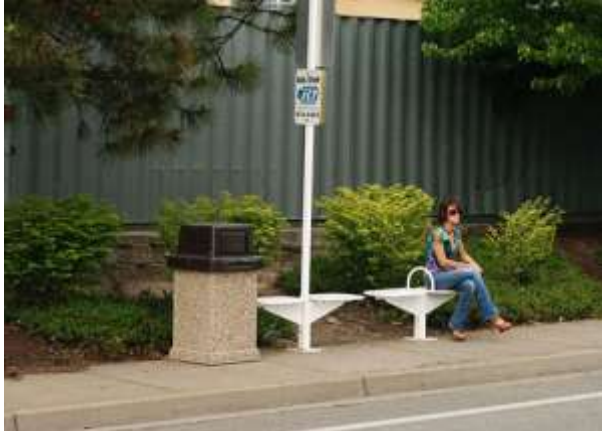
As a unique alternative to typical freestanding benches, 1, two or more stools may be considered at low ridership stops or where there are narrow sidewalks. Stools may be freestanding or may be attached to the bus stop sign post.

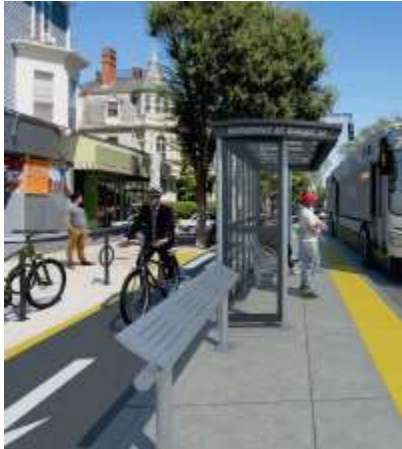
Leaning rails may also be used in place of traditional benches. They are particularly useful at floating bus stops as they help establish a narrow barrier between the bus island and the bike lane behind it, deterring riders from crossing the bike lane in non-designated spots.

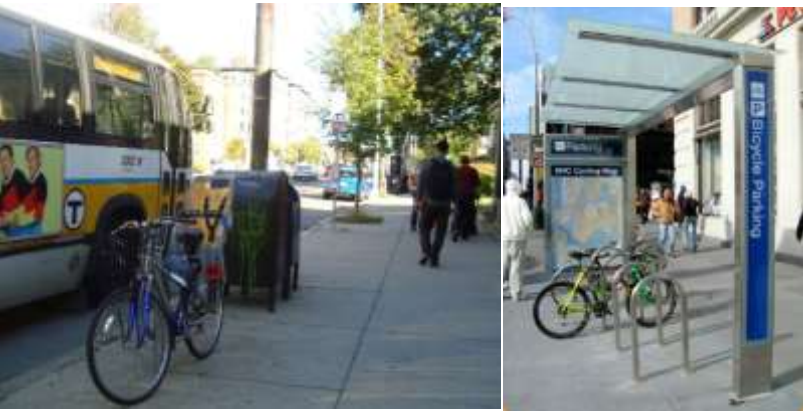
Bicycle Connectivity

The installation of bicycle parking at bus stops expands rider connections to and from origins/destinations, especially for first-mile last-mile connections, and can incentivize transit users to ride their bicycle to access transit. Furthermore, they provide a bicycle parking option for riders if the bicycle rack on the bus is already at capacity. Providing sufficient designated bicycle parking prevents bicycles from being locked to other streetscape objects such as poles and fences, which helps improve the attractiveness of the surrounding environment. Bike racks should have at least two points of contact with the bike and be placed outside of the path of travel in the bus stop and positioned so that no matter how a bicycle is locked to it, it will not obstruct the path of travel.

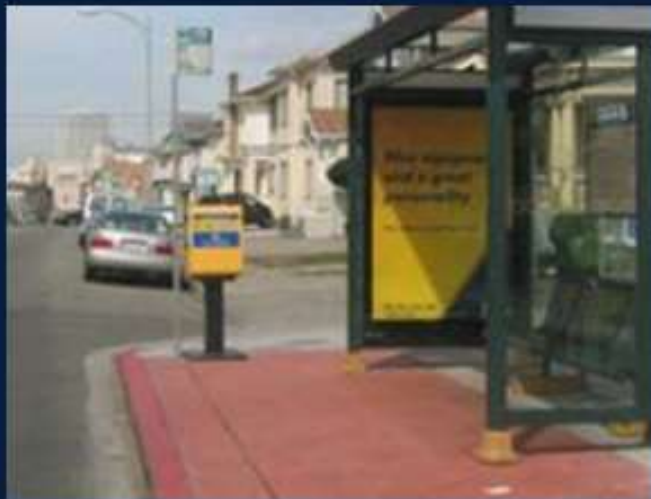
- 1. Painted or in-mix colored concrete.
(Oakland, CA)**

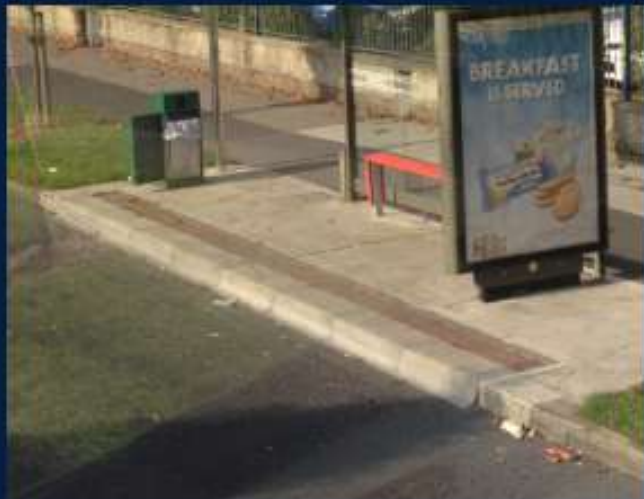
- 2. Brick edge between the sidewalk and the curb distinguishes the bus stop zone. If the sidewalk is brick, altering the pattern can also provide distinction. (Dublin, Ireland)**

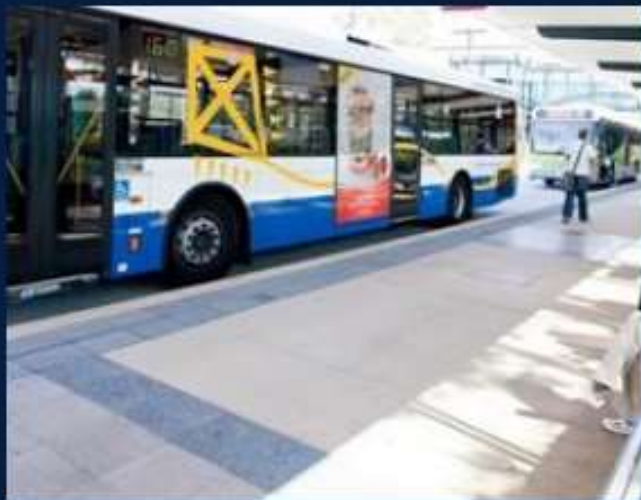
- 3. Textured sidewalk with features to designate the boarding area. (Brisbane, Australia)**

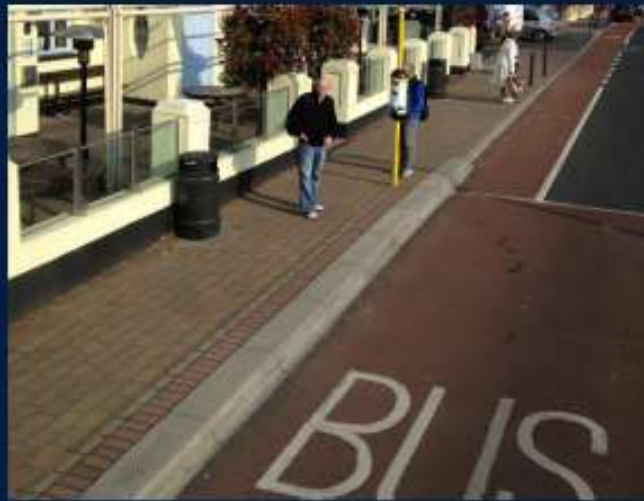
- 5. Alternative curb design that could be angled at the face of curb and or tactile treatment at top of curb. (Dublin, Ireland)**

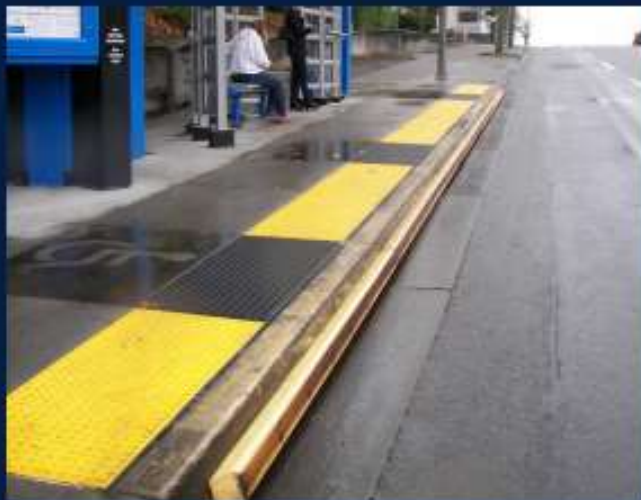
- 4. Tactile warning strip. (Puget Sound, WA)**

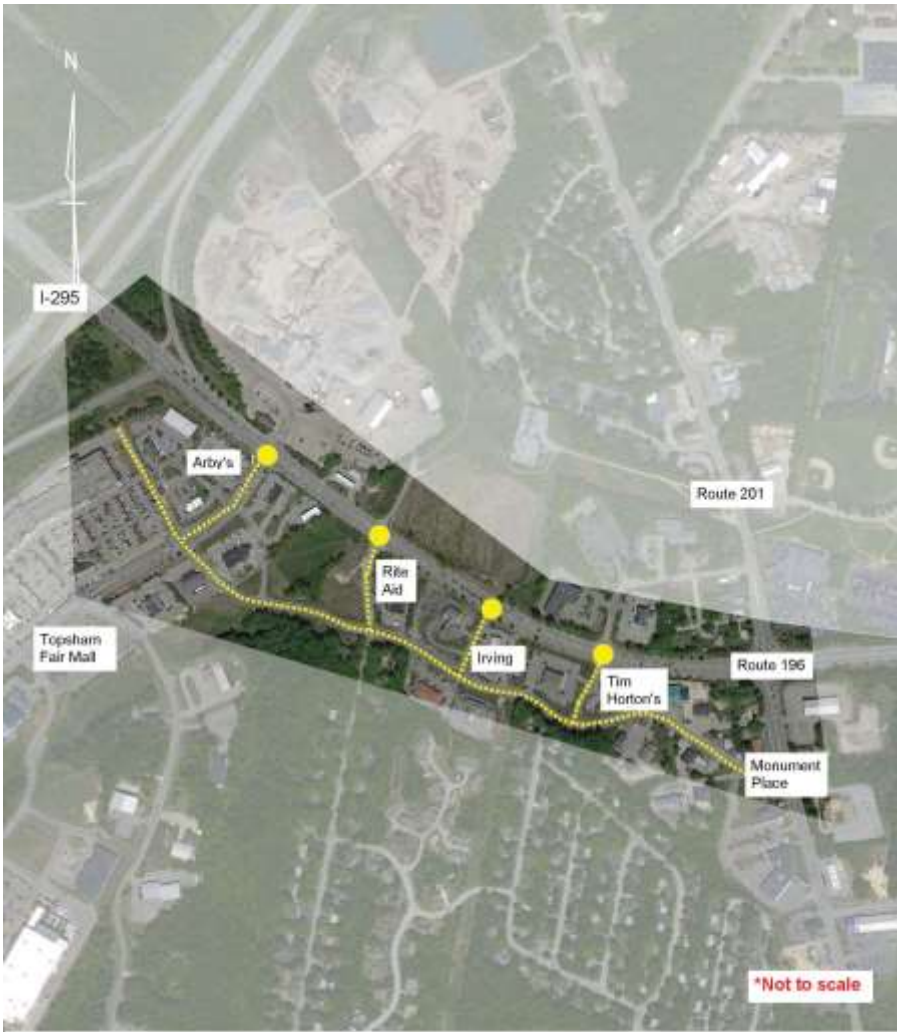
Topsham, ME Connector Road Example

As communities grow and land is subdivided for development, it is essential to assure continuation and extension of the existing local street system. Dead end streets, cul-de-sacs, and gated communities force more traffic onto collectors and arterials. Fragmented street systems also impede emergency access and increase the number and length of automobile trips. A connected road network advances the following growth management objectives
