Scarborough, ME

Payne Road and Gorham Road

Road Safety Audit Report

Virtual RSA meeting: 11/17/2020, Field review: 11/18/2020

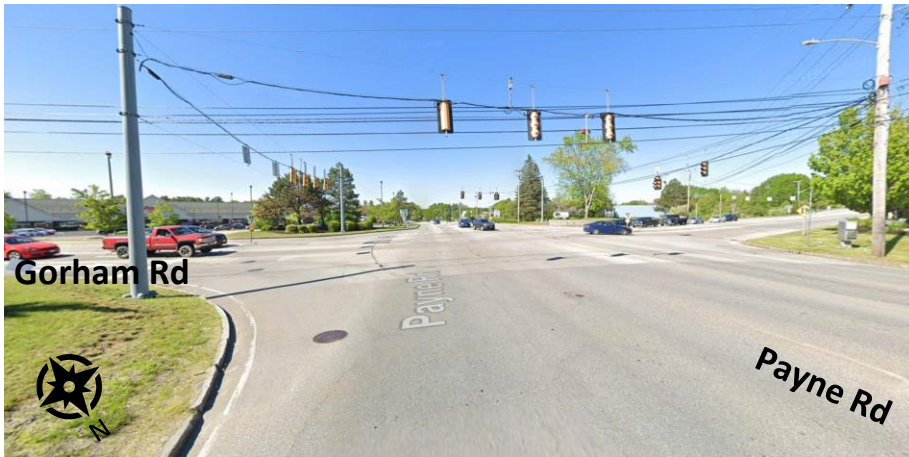
- This intersection is very large in overall width and length, and includes increased turning radii for truck traffic through the intersection.
- There are multiple turning lanes from many of the approaches, which may contribute to motorist's confusion.
- There have been reports of the eastbound Gorham Road (Rt 114) approach significantly backing up during the morning commuting hours even with dual left turning lanes onto Payne Road.
- The lane designations, and travel patterns for those commuting through the intersection should be reexamined.

Street view of intersection at Payne Road and Gorham Road traveling South on Payne Road, from Google Maps

- Investigate speed of vehicles on eastbound Gorham Road, approaching the Payne Road intersection.
- Observe conditions to note if aggressive driving is prevalent. If so, consider conducting aggressive driving enforcement and providing educational messaging.
